SUREHOME OF BREVARD

# Full Home Inspection

PROPERTY INSPECTED  
450 Sample Way, Palm Bay

DATE INSPECTED  
July 29, 2026

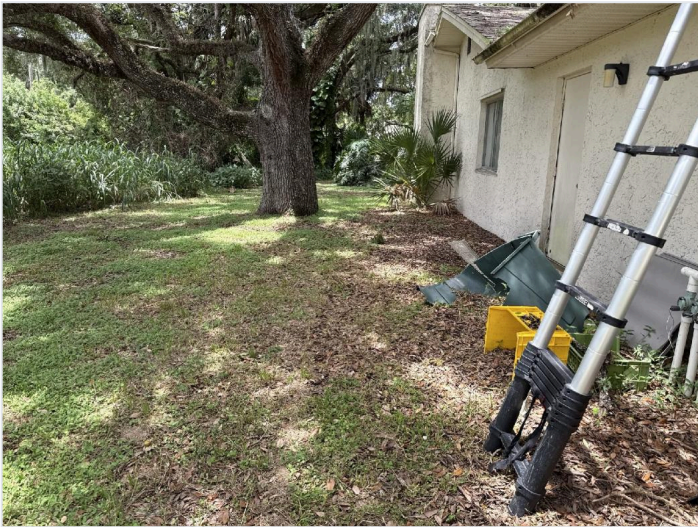
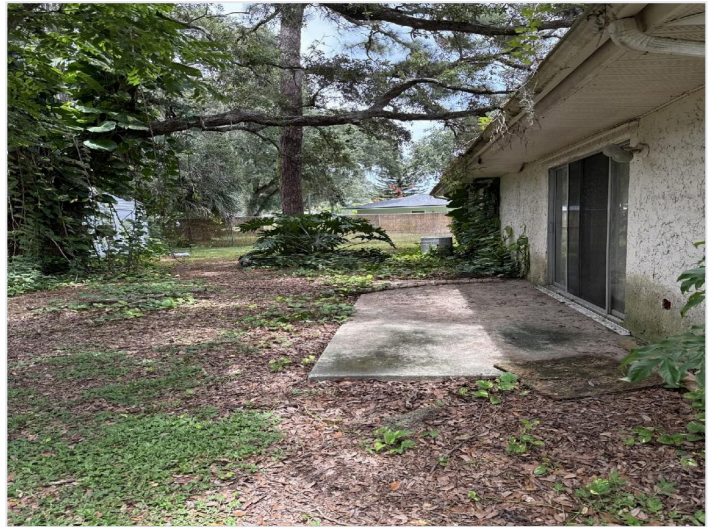
### Vegetation/Debris

⚠ Tree limbs within 10 feet of roof should be trimmed to provide air and sunlight, minimizing debris & dampness. Tree above roof should be removed. Cost \$6-8K 🚩

**Recommended:** Hire a certified arborist to trim tree limbs within 10 feet of the roof and remove the tree above the roof to prevent debris accumulation and moisture damage.

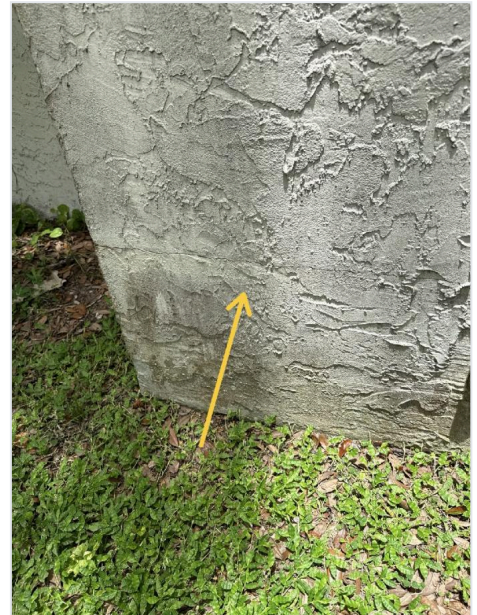
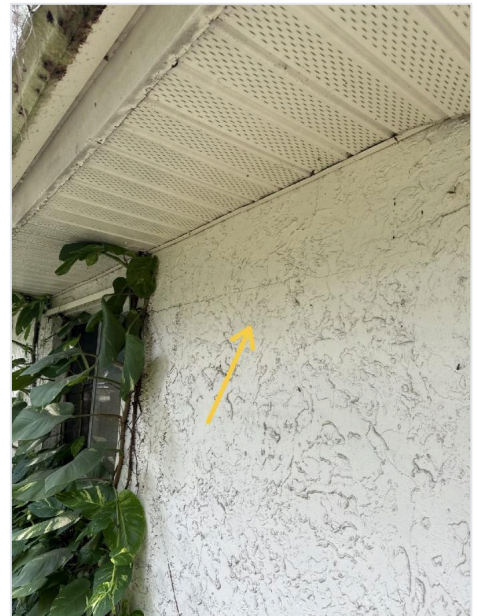
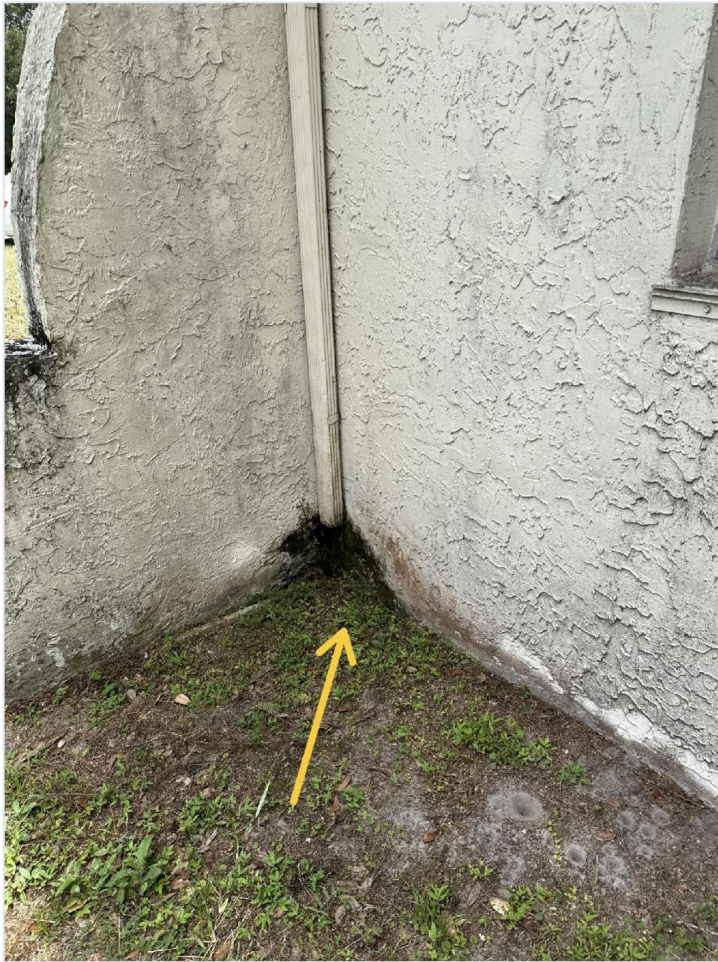
**Siding Condition**

⚠ Major damage to siding: Should be repaired to prevent moisture and insect intrusion of the wall assembly. Vegetation has taken over large areas of siding. Stucco cracks and large holes in stucco evident.

**Recommended:** Have a licensed contractor inspect and repair major siding damage, remove vegetation overgrowth, and seal stucco cracks and holes to prevent moisture and pest intrusion.

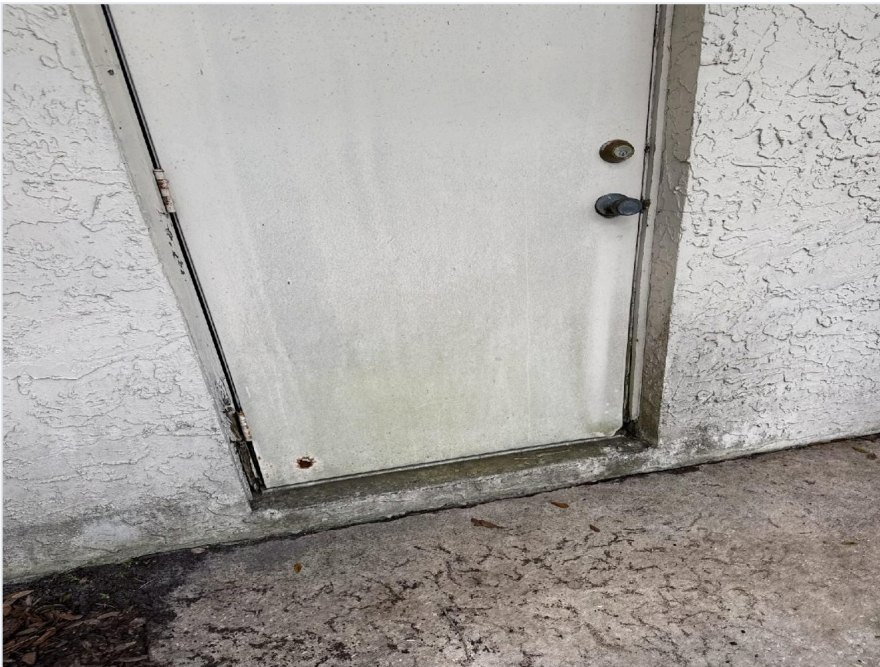
### Doors

⚠ Side door didn't close or seal properly. Wood rot and rust at bottom. Door frame damage. 🚩

- 2. House Exterior — Doors** → p. 9  
Side door didn't close or seal properly. Wood rot and rust at bottom. Door frame damage.  
**Recommended:** Have a licensed carpenter or door specialist repair or replace the side door, address wood rot and rust, and restore the door frame to ensure proper closure and sealing.

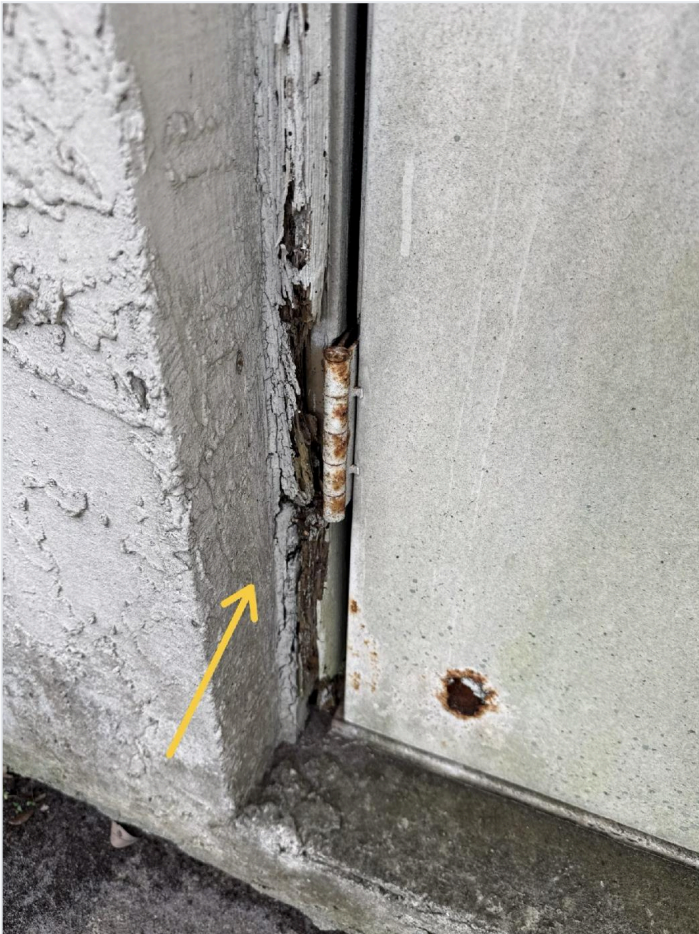
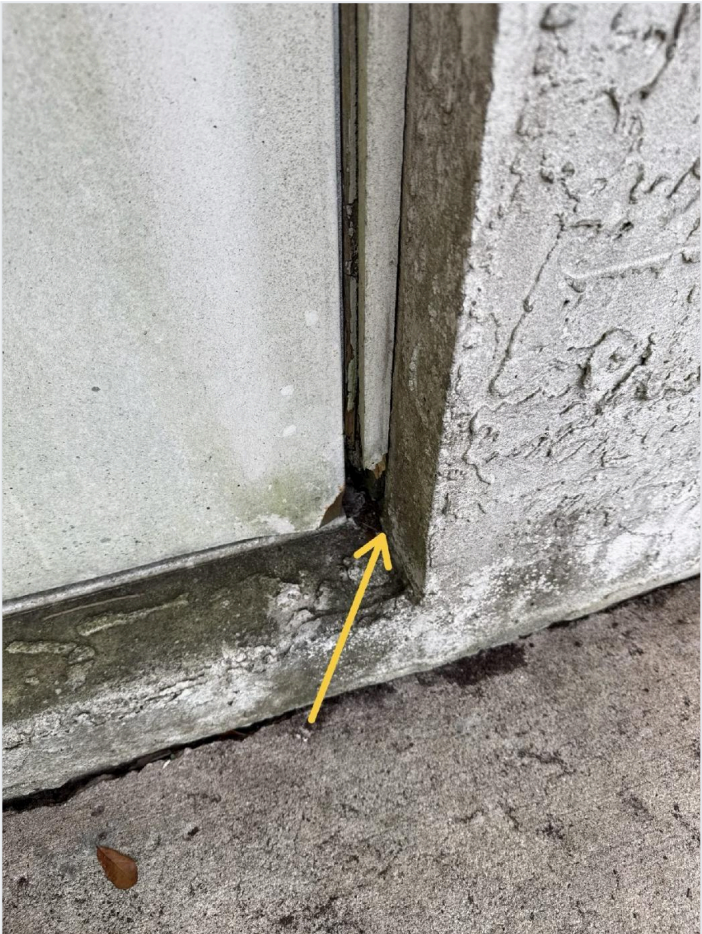
Stucco                      ⚠ Small holes & gaps noted in stucco. Recommend sealing & painting to prevent water intrusion. 🚩

**Recommended:** Seal and paint all small holes and gaps in the stucco to prevent water intrusion into the wall assembly.

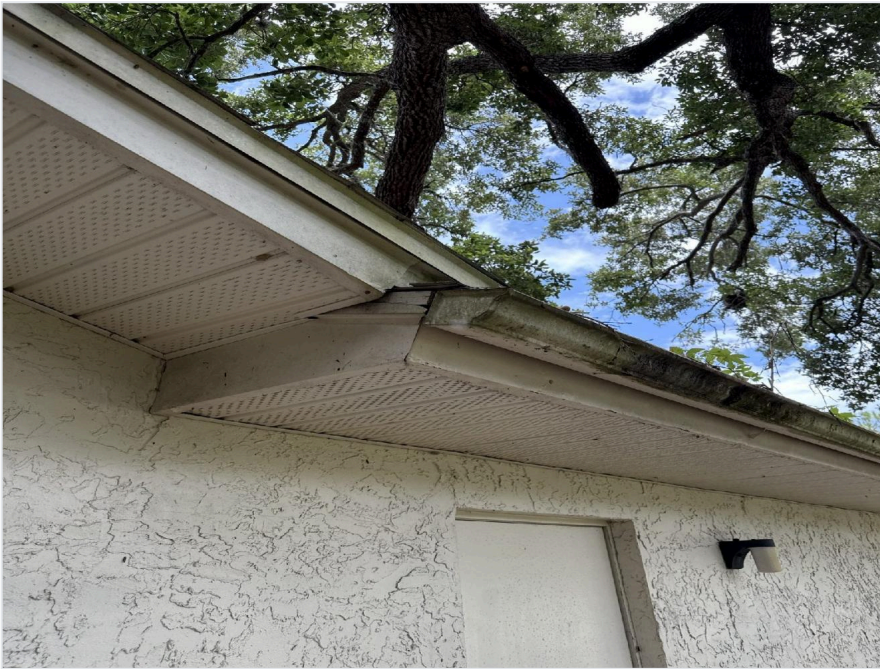
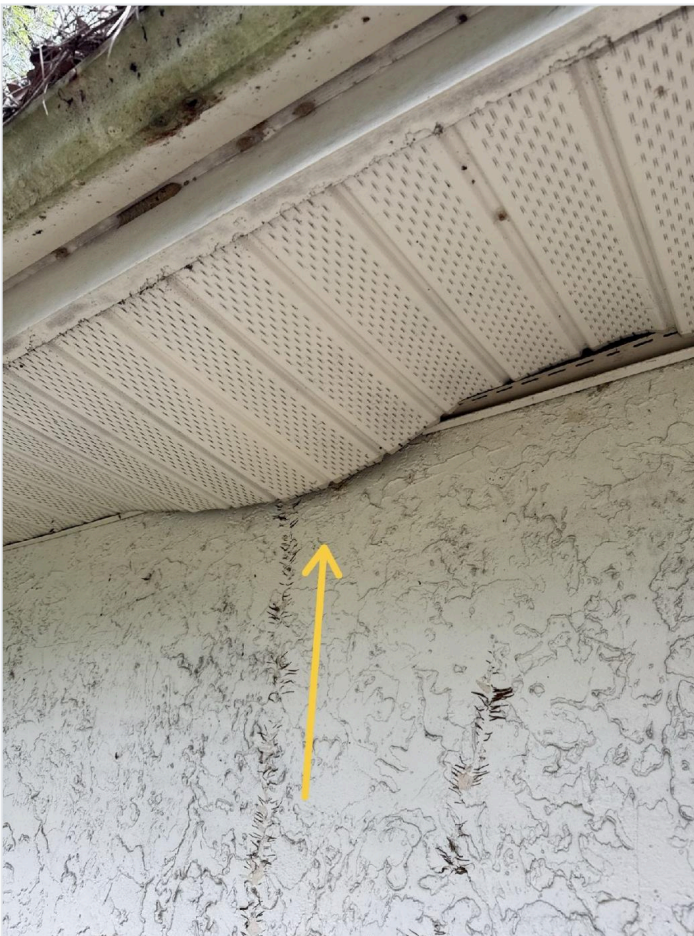
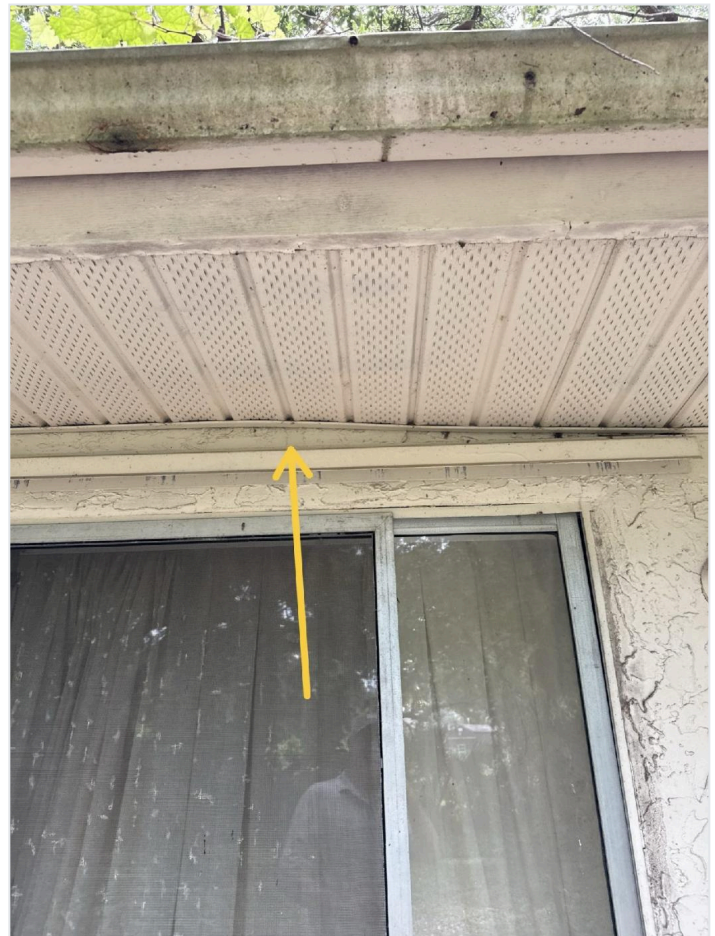
Soffits missing, loose or detached. Suggest repair or replacement.

**Recommended:** Have a qualified roofing contractor repair or replace missing, loose, or detached soffits.

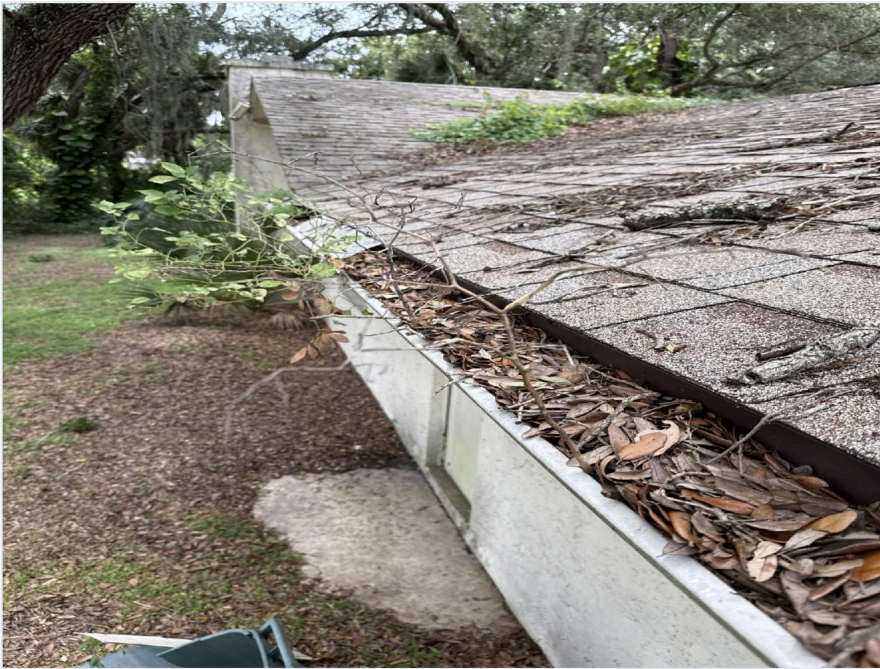
### Gutters

⚠ Significant amounts of debris evident in gutters. Recommend regular cleaning. 🚩

**Recommended:** Clean gutters immediately and establish a regular cleaning schedule at least twice yearly to prevent debris accumulation.

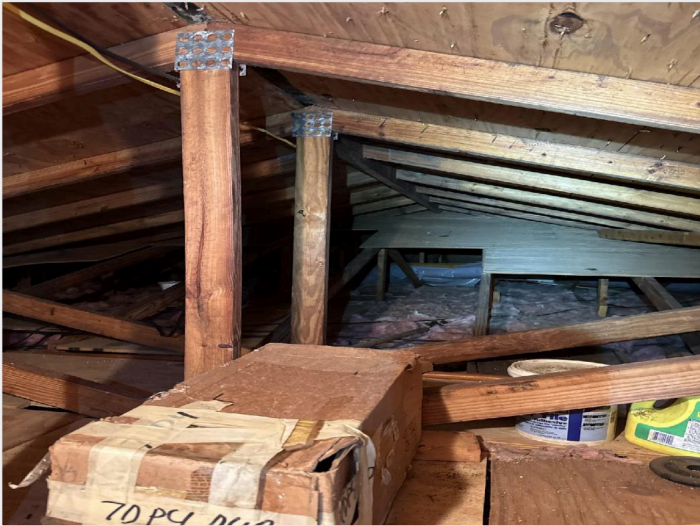
Damage or tears to exterior wrapping of ductwork noted. Recommend evaluation by HVAC professional.

**Recommended:** Have an HVAC contractor clean the dusty and rusty air supply vents, inspect the ductwork, and repair or replace torn ductwork with exposed insulation in the attic.

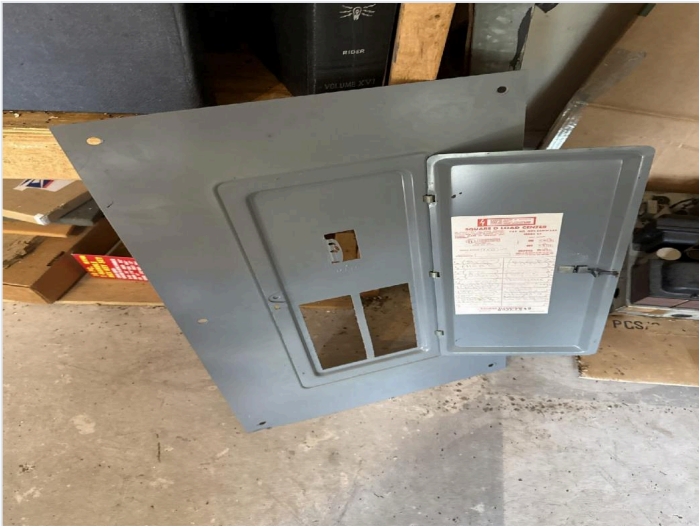
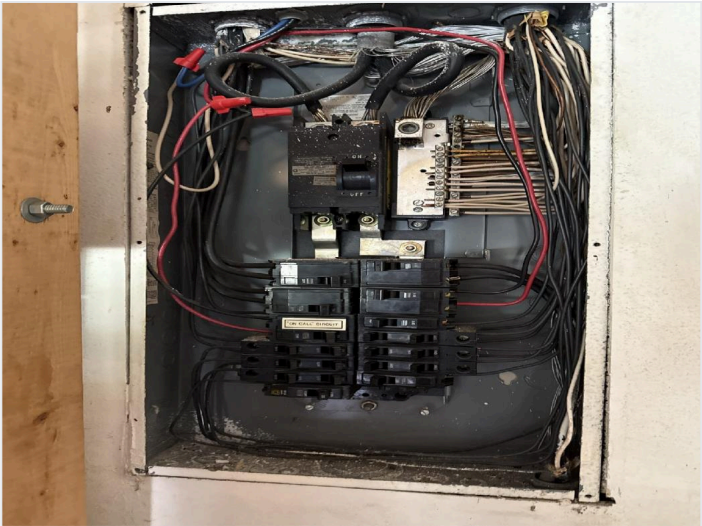
| Panel Issues | <p>Copper non-metallic sheathed cable noted.</p> <p>⚠️ Aluminum non-metallic sheathed cable noted. Considered a fire hazard by many insurance companies. Common for 1975-1985 builds.</p> <p>⚠️ Double tapped breaker(s) inside panel box (more than one electrical wire attached). This is not standard practice, and may cause overheating or even an electrical fire. Recommend evaluation by an electrician. 🚩</p> |

**Recommended:** Have a licensed electrician inspect the aluminum non-metallic sheathed cable and replace it with modern wiring to eliminate the fire hazard and satisfy insurance requirements.

**Recommended:** Have a licensed electrician immediately evaluate and correct the double-tapped breaker(s) in the panel box to prevent overheating and electrical fire risk.

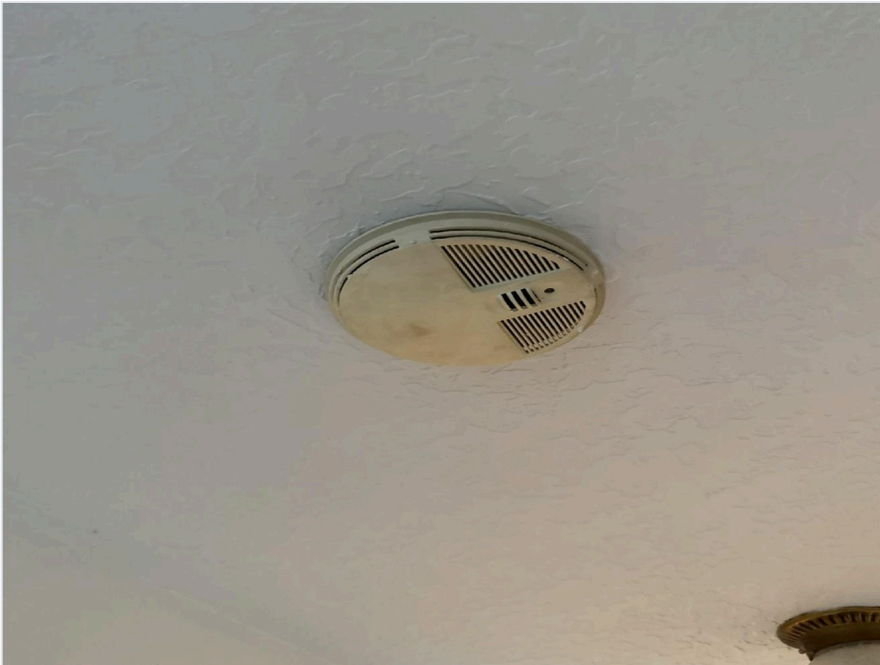
#### Smoke Det

⚠ Smoke detectors were tested and are NOT functional. 🚩

**Recommended:** Replace all non-functional smoke detectors immediately with new units and test them to ensure proper operation.

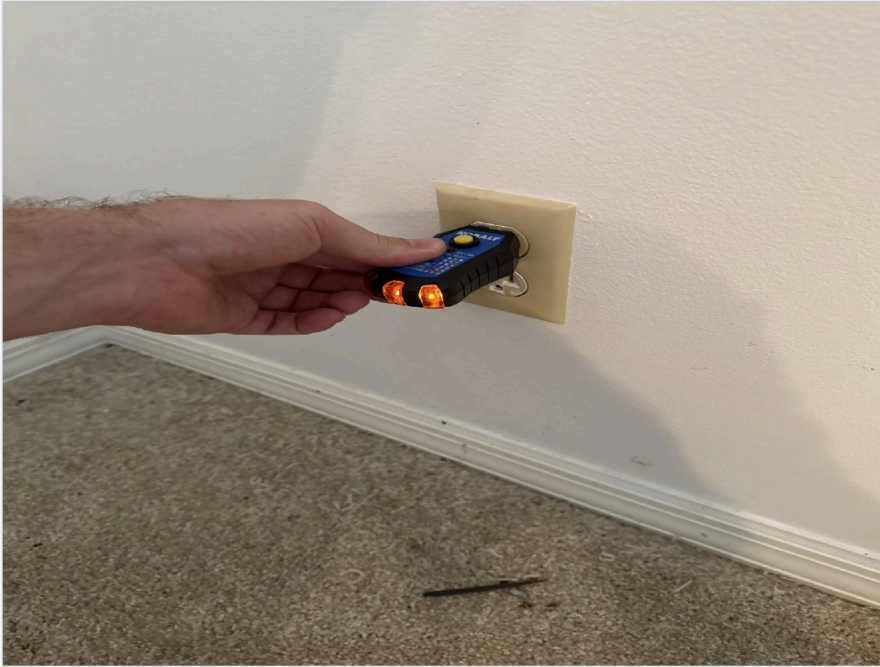
⚠ Hot-neutral reversed outlets present, which may damage

appliances or electronic devices. Recommend repair. ■

**Recommended:** Have a licensed electrician identify and correct all hot-neutral reversed outlets to prevent damage to appliances and eliminate electrical hazards.

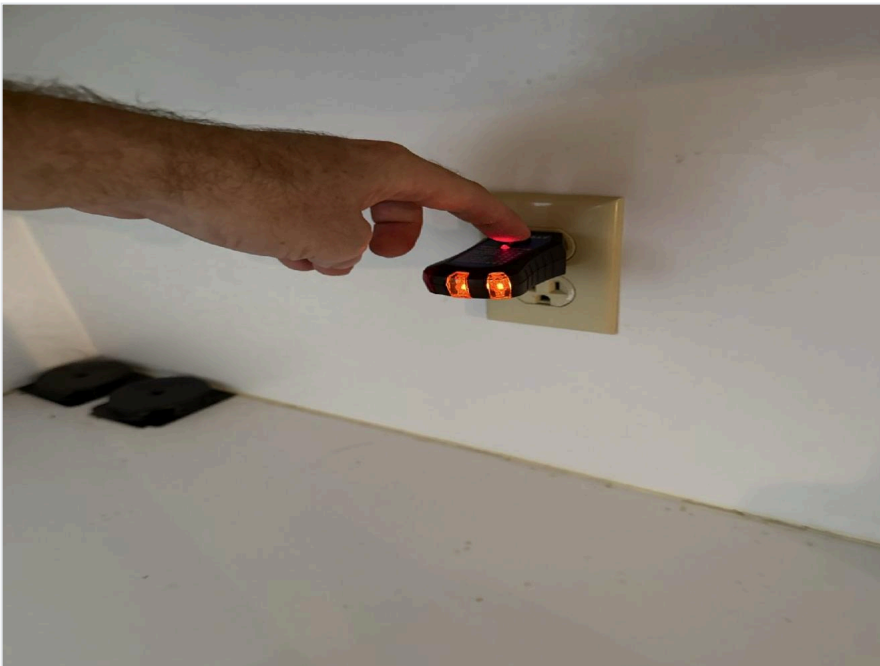
⚠ GFCI protected receptacles may not have been required when the house was built. Recommend upgrading all receptacles within 6 feet of potential wet locations to GFCI protection. ■

**Recommended:** Upgrade all receptacles within 6 feet of wet locations (bathrooms, kitchen, laundry) to GFCI-protected outlets to meet current safety standards.

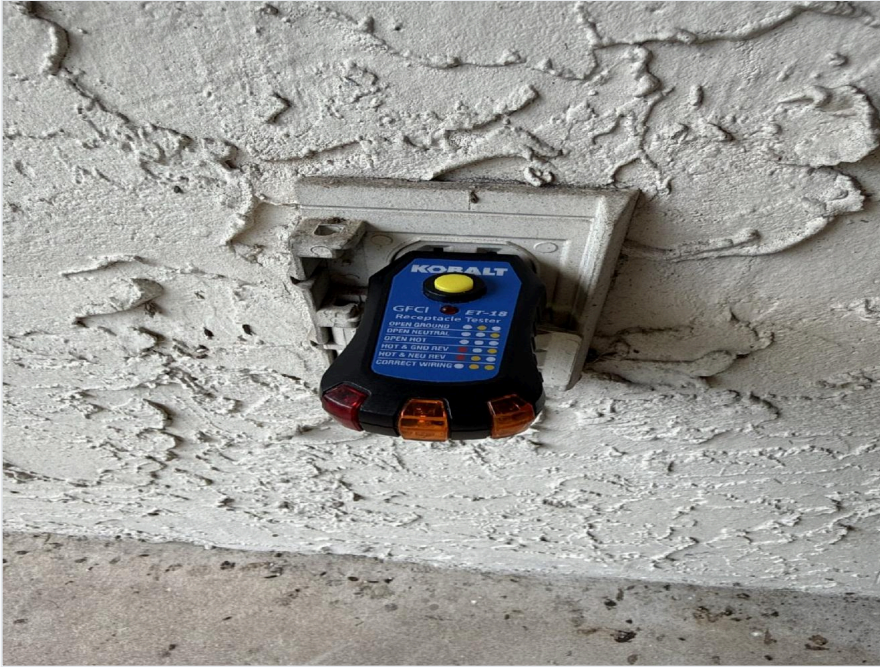
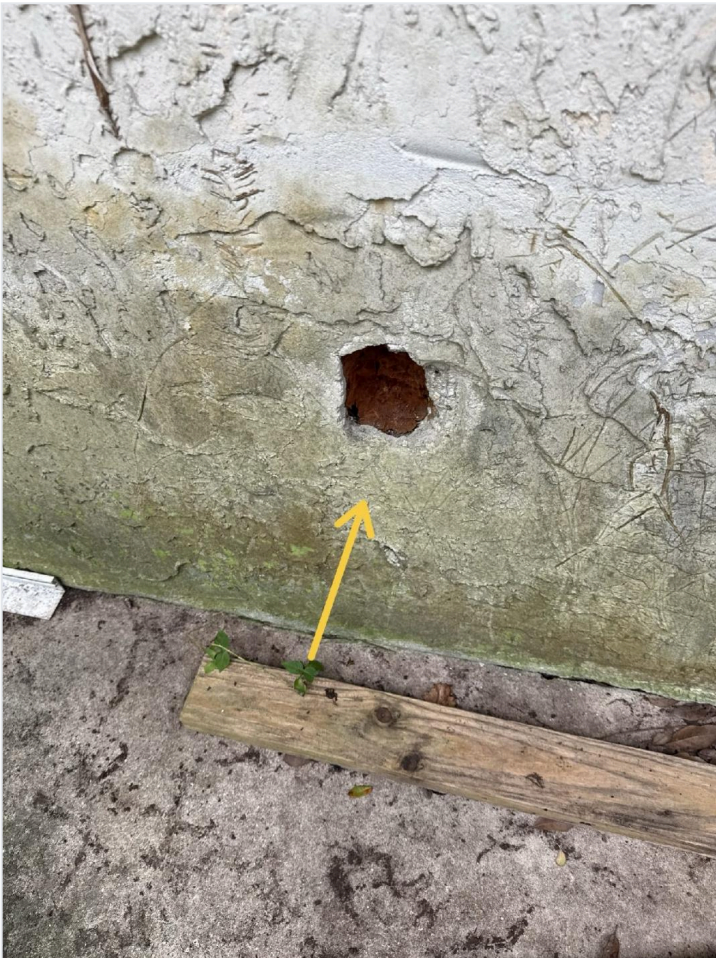
Ext Electrical

⚠ Exterior outlets are not GFCI protected. Although this may not have been required when the home was built, consider upgrading to

GFCI protection in any outdoor or moisture-prone areas. ■

**Recommended:** Install GFCI protection on all exterior outlets to protect against shock hazards in moisture-prone areas.

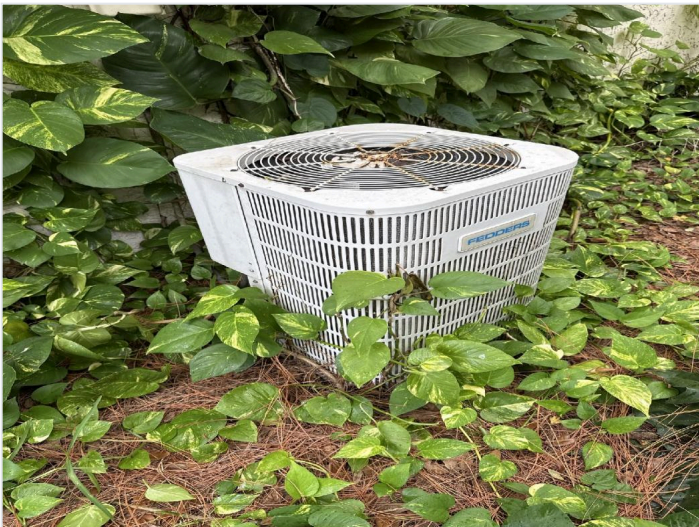
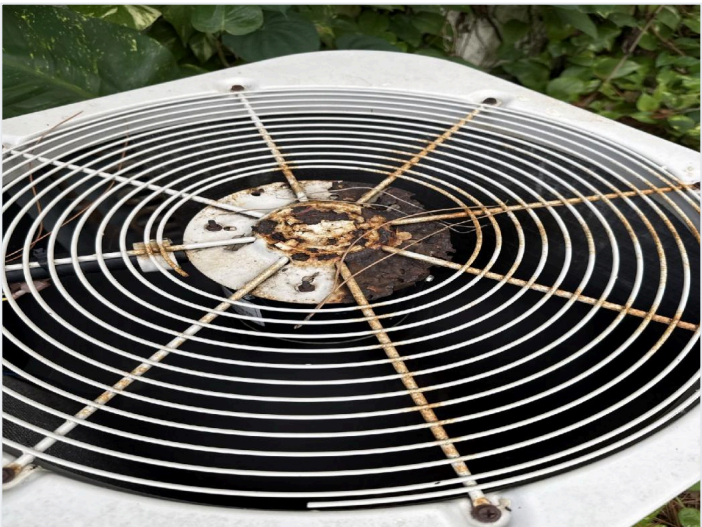
| HVAC Condition | ⚠️ Recommend cleaning and yearly maintenance of AC compressor. Compressor has vegetation very close or on unit. This will cause early failure. 🚩 |

**Recommended:** Clear vegetation away from the AC compressor unit and schedule professional cleaning and yearly maintenance to prevent early failure.

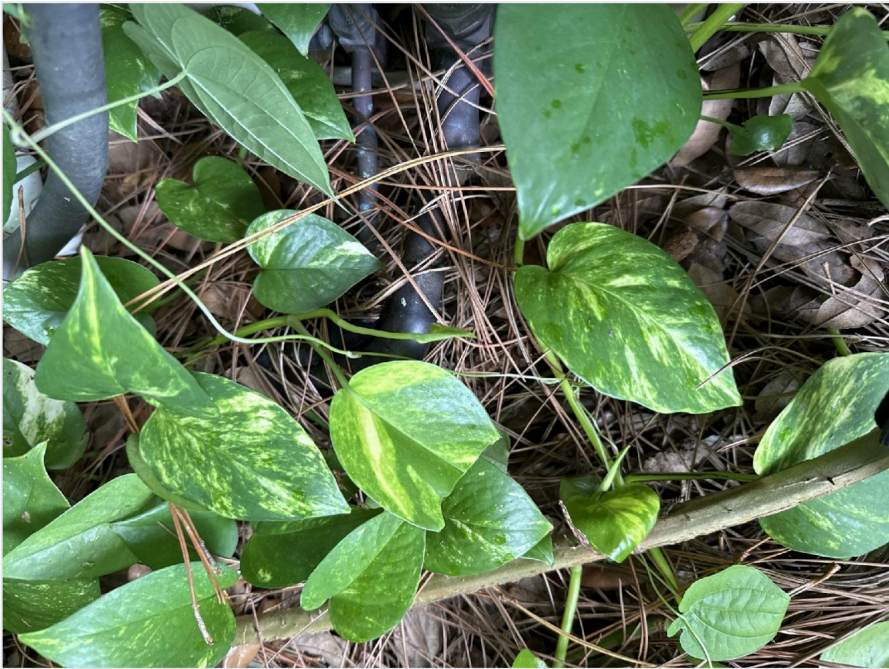
| Refrigerant/Drain Lines | ⚠️ Recommend adding insulation at A/C refrigerant lines to prevent condensation and energy loss. 🚩 |

**Recommended:** Have an HVAC technician add insulation to the A/C refrigerant lines to prevent condensation and reduce energy loss.

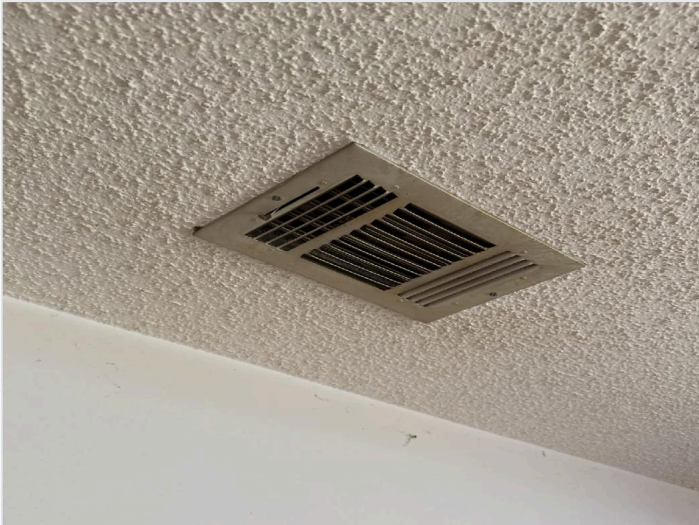
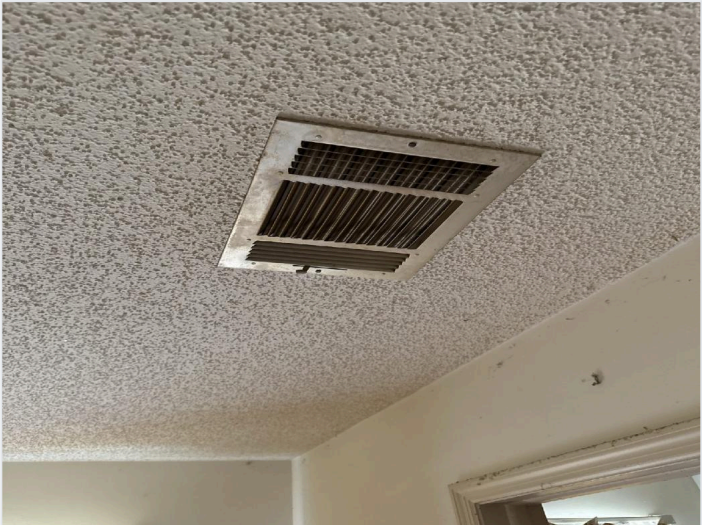
| HVAC Vents | ⚠ The air supply system vents appear dusty and rusty. Ductwork in attic is torn and has exposed insulation. 🚩 |

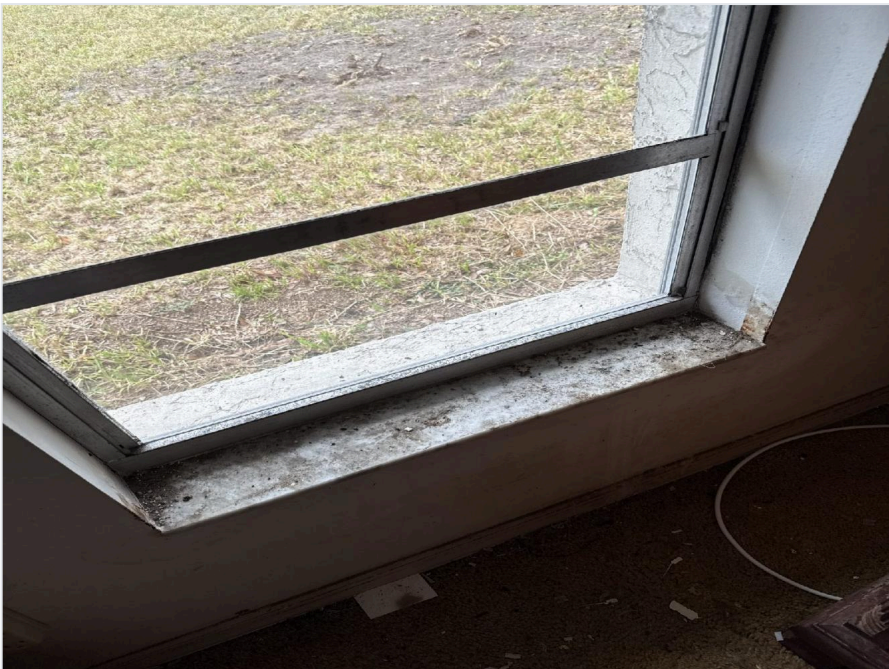
Windows Condition

- ⚠ Window hardware damaged. Recommend repair.
- ⚠ Window binds in frame. Recommend evaluation by window specialist. 🚩

**Recommended:** Repair or replace damaged window hardware to restore proper function and security.

**Recommended:** Have a window specialist evaluate why windows bind in their frames and make necessary adjustments or repairs.

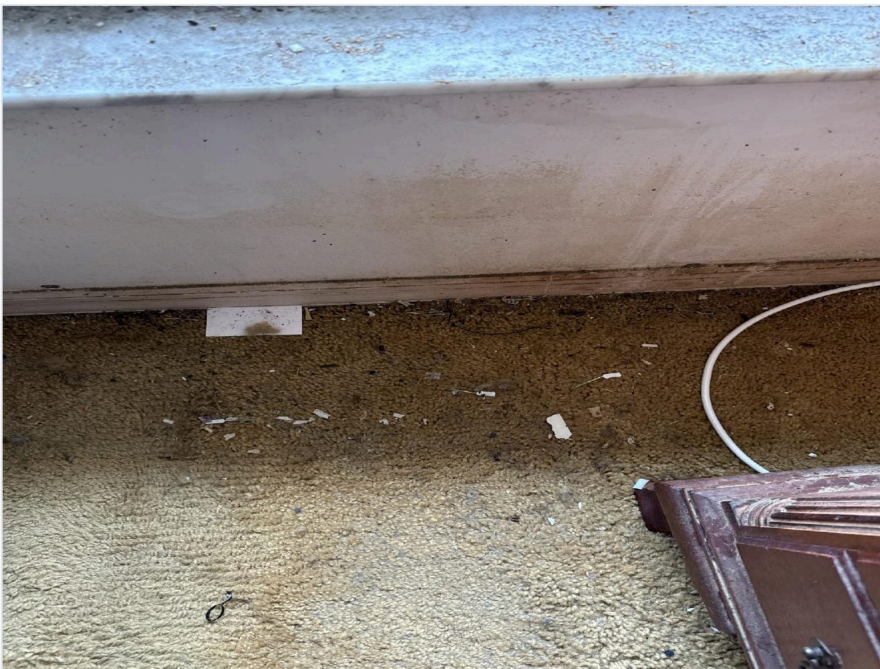
#### Floors Condition

⚠ Water damage observed on flooring. Windows likely leak in a wind-blown storm. 🚩

**Recommended:** Have a contractor inspect window seals and frames, and repair leaks to prevent further water damage to flooring.

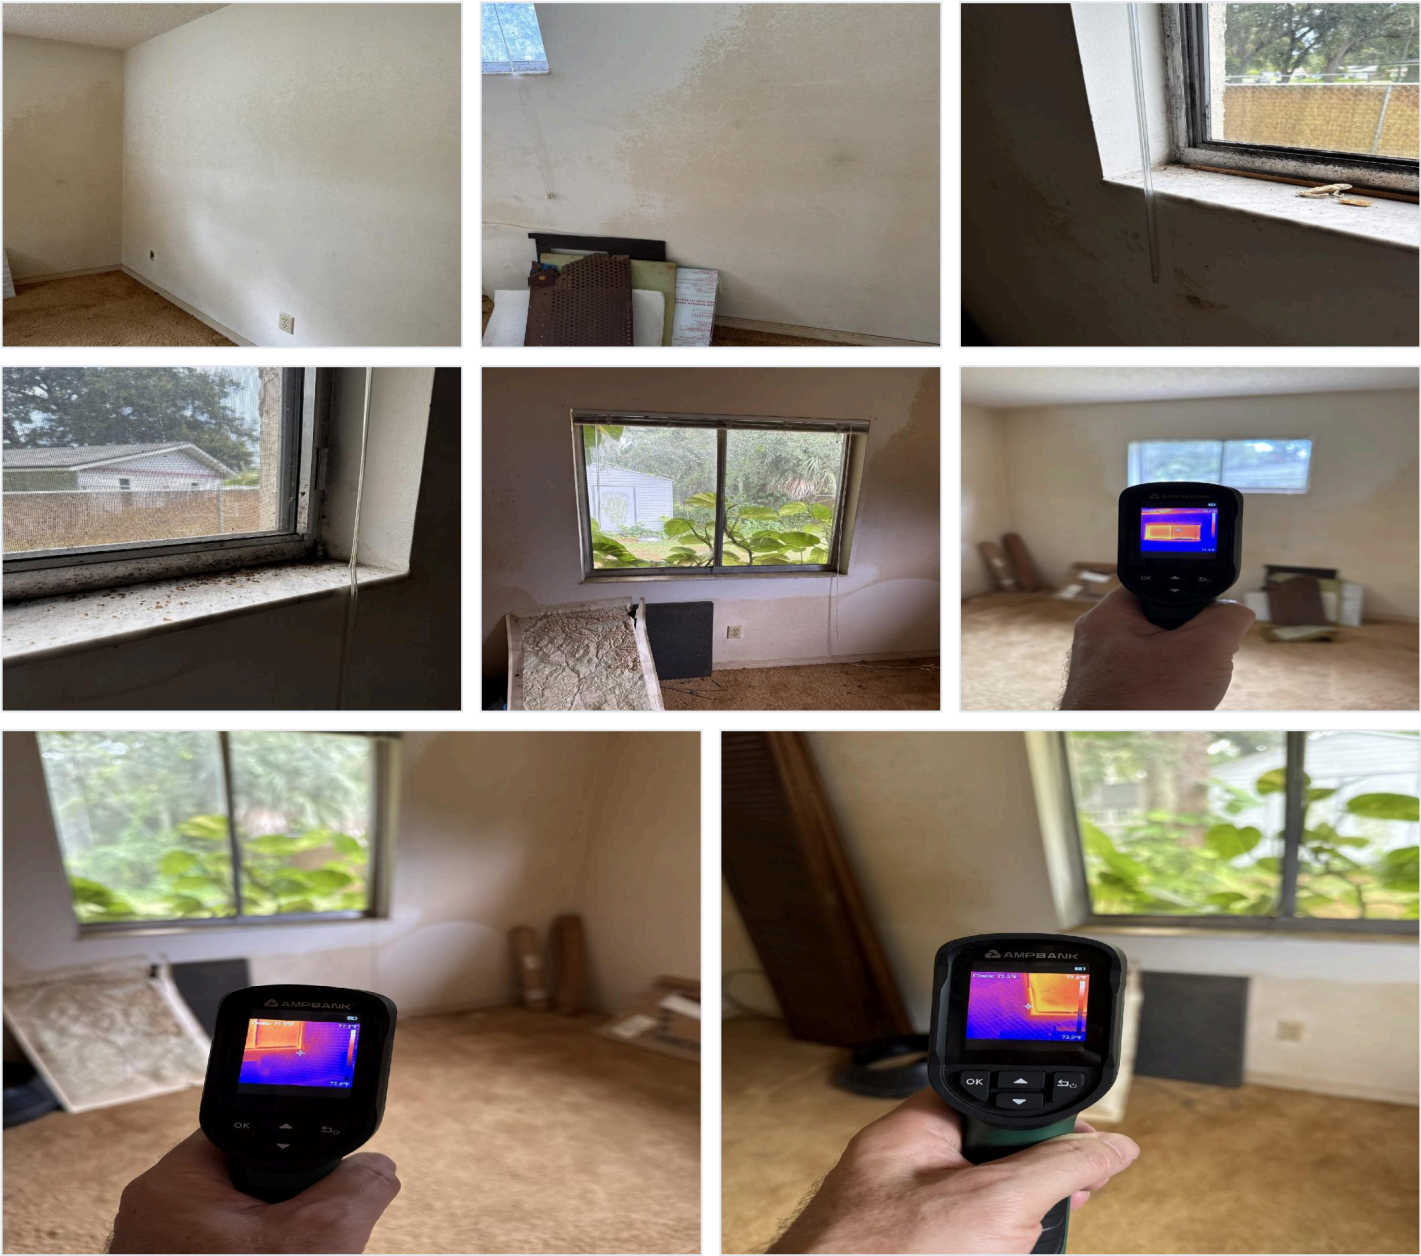
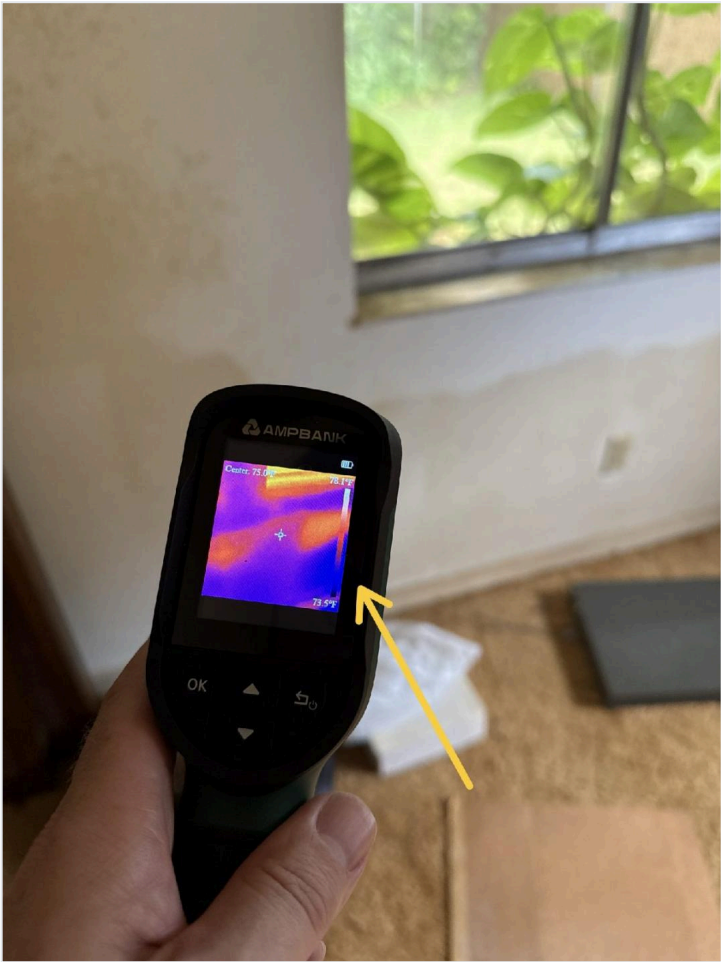
#### Walls - Condition

⚠ Stains on walls indicate possible water intrusion. Recommend evaluation by a contractor to determine if leak is still active and make repairs. 🚩

**Recommended:** Contact a qualified contractor to investigate the water stains on walls, determine if leaks are active, and make necessary repairs to stop moisture intrusion.

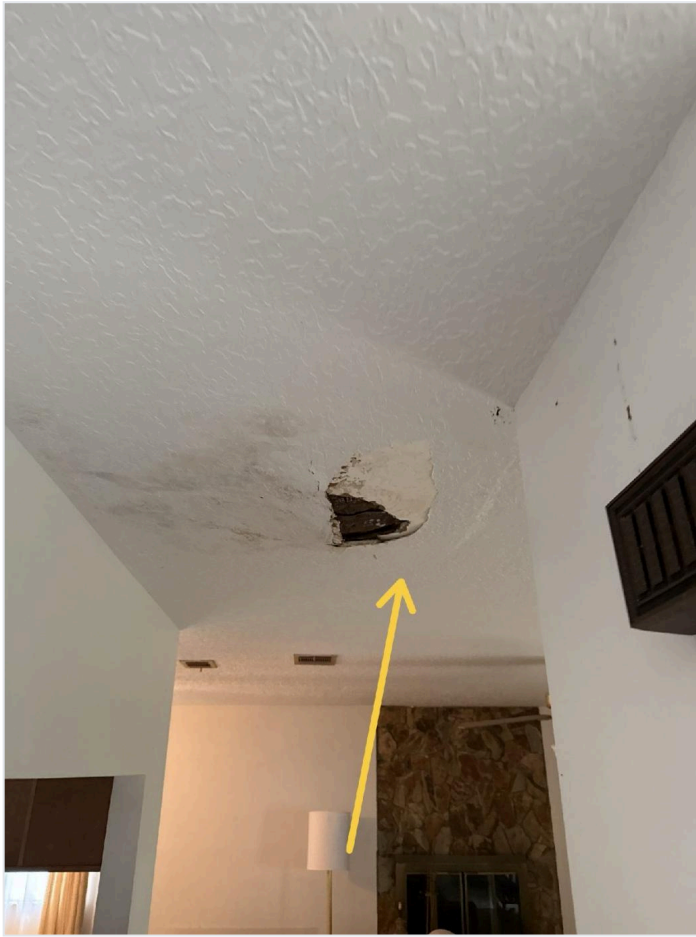
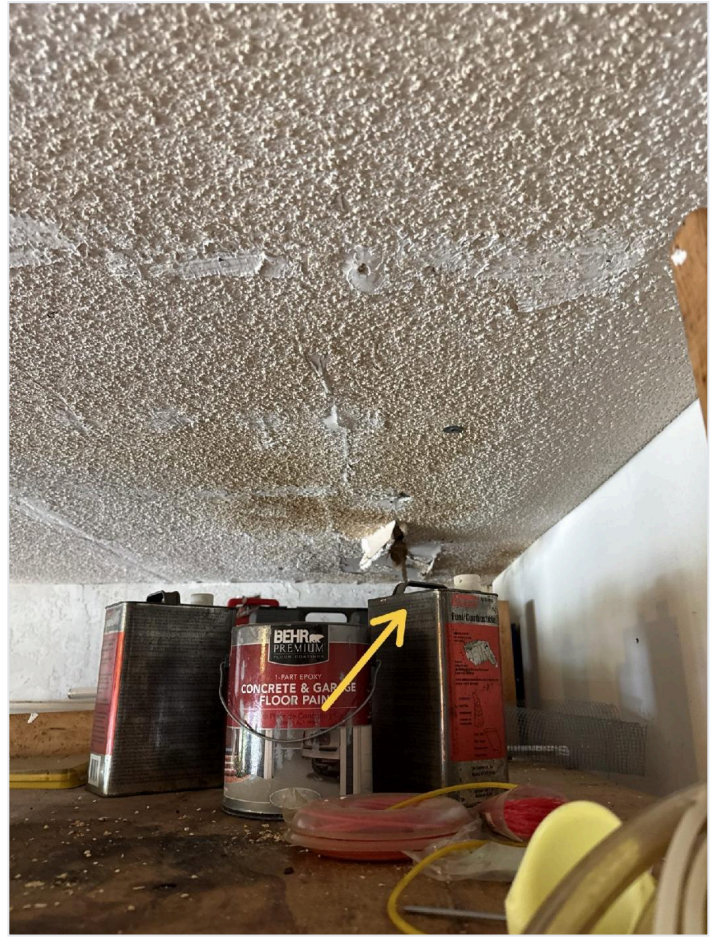
Ceilings - Condition

⚠ Visible leaking noted on the ceiling. We recommend contacting a qualified contractor to evaluate the roof and the drywall in this area and repair as necessary. 🚩

**Recommended:** Immediately contact a qualified contractor to evaluate the roof, identify the active leak source, and repair both the roof and damaged drywall in the affected area.

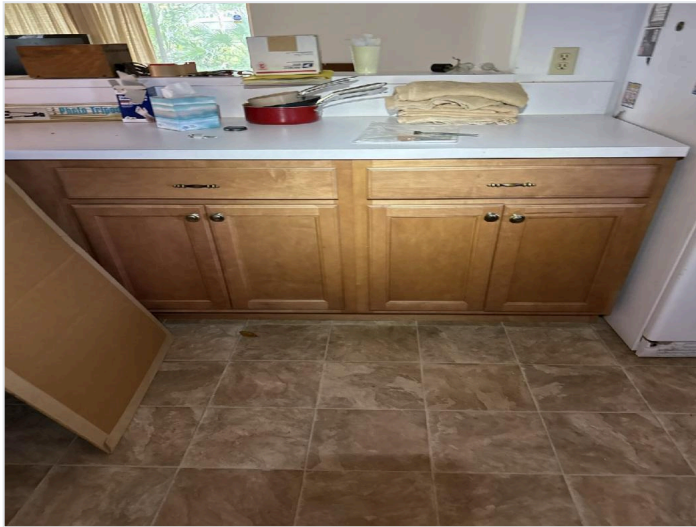
⚠ There appears to be water damage under the sink. This tested dry at the time of the inspection, but monitor for any further intrusion. 🚩

**Recommended:** Monitor the area under the sink for any additional water intrusion and repair the source of the previous water damage if leaking resumes.

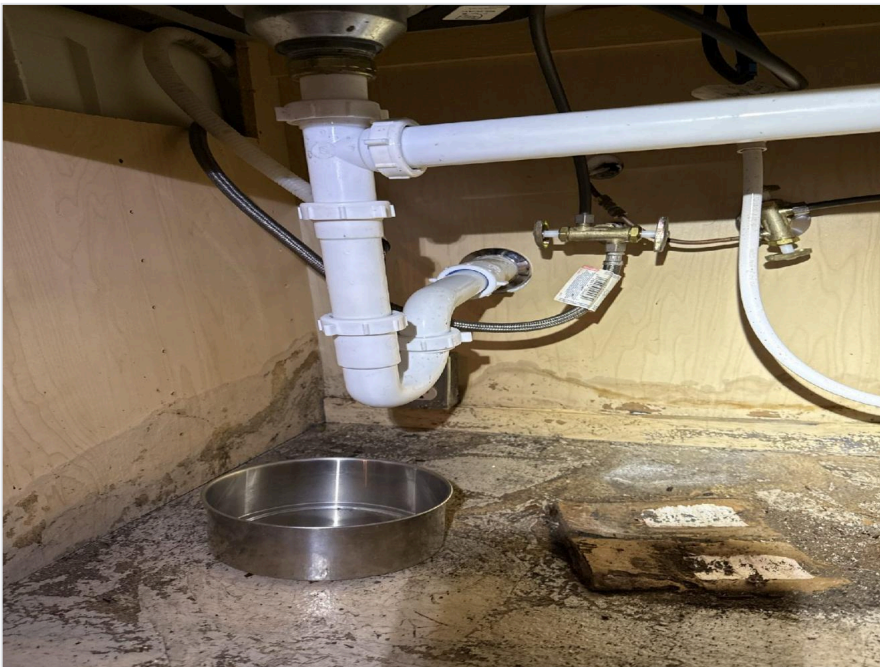
#### Dishwasher

⚠ Dishwasher was visually reviewed and operated through a cycle during the inspection. Did not drain. 🚩

**Recommended:** Have a licensed plumber inspect and repair the dishwasher drain to restore proper drainage function.

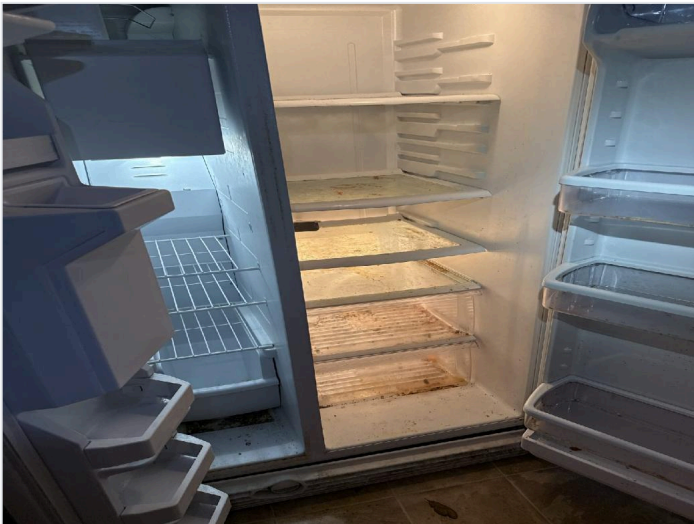
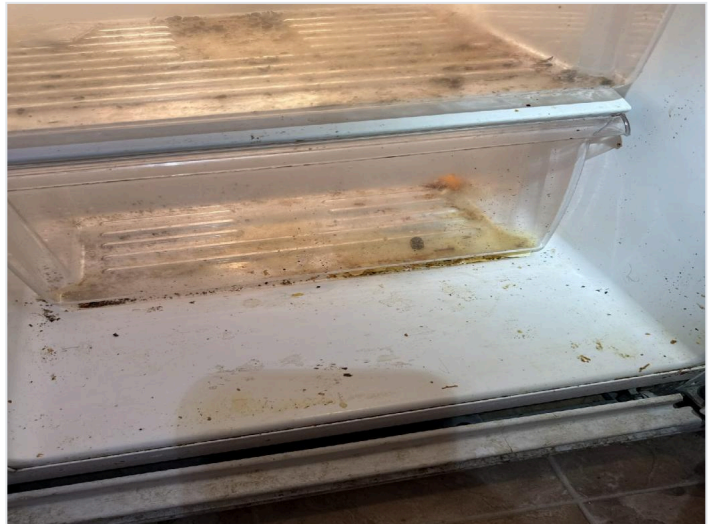
Fridge - Condition

⚠ Refrigerator very dirty with active bugs. 🚩

**Recommended:** Clean the refrigerator thoroughly and address the active insect infestation immediately; consider professional pest control treatment if necessary.

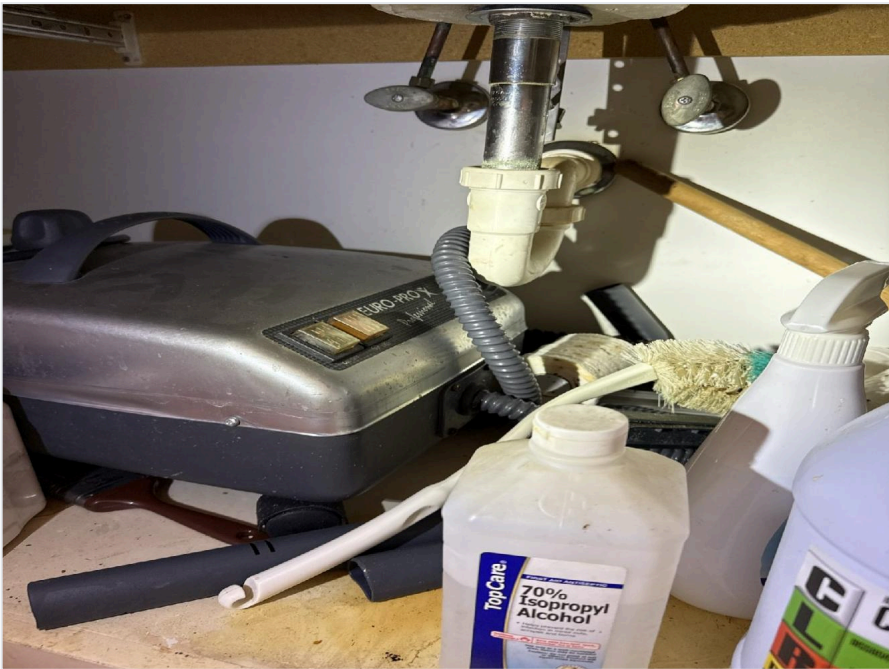
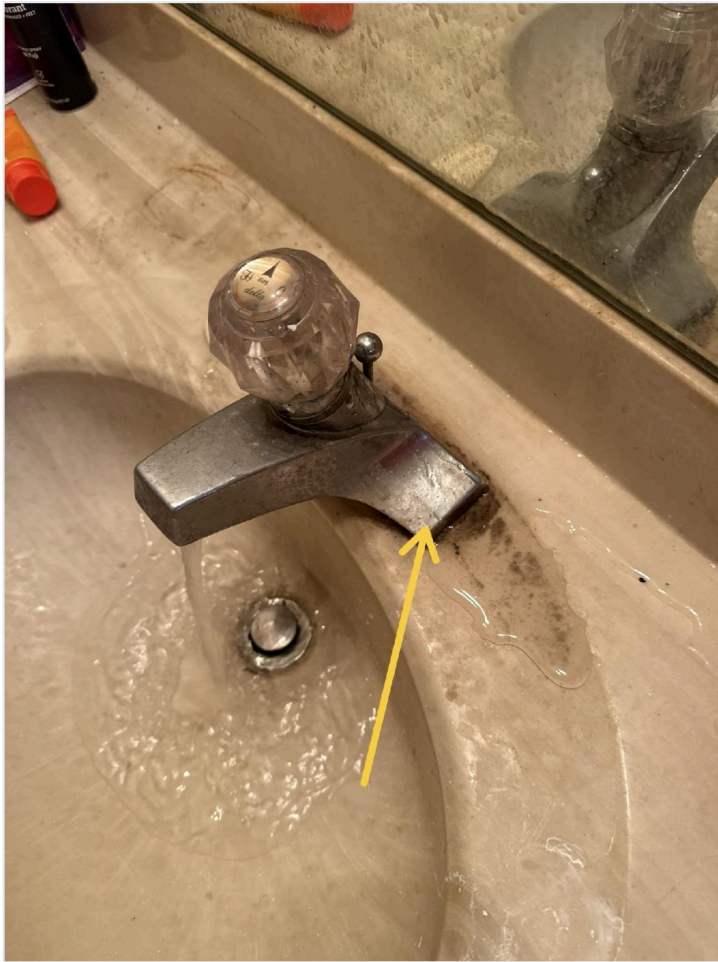
| Plumbing | Bathroom sink equipped with proper P-trap drain plumbing and was free of leaks at the time of inspection.<br>⚠ Minor leak observed at sink fixture. Recommend replacement of fixture. 🚩 |

**Recommended:** Have a licensed plumber replace the leaking sink fixture to prevent further water damage.
