SUREHOME OF BREVARD

# Full Home Inspection

PROPERTY INSPECTED  
450 Sample Way, Palm Bay

DATE INSPECTED  
July 29, 2026

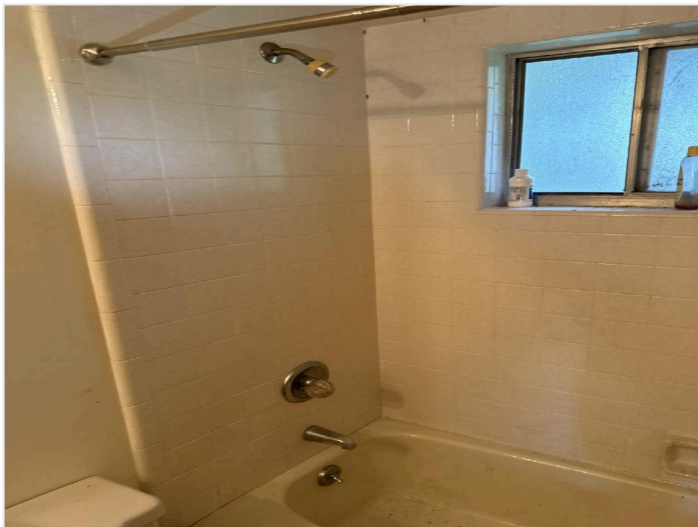
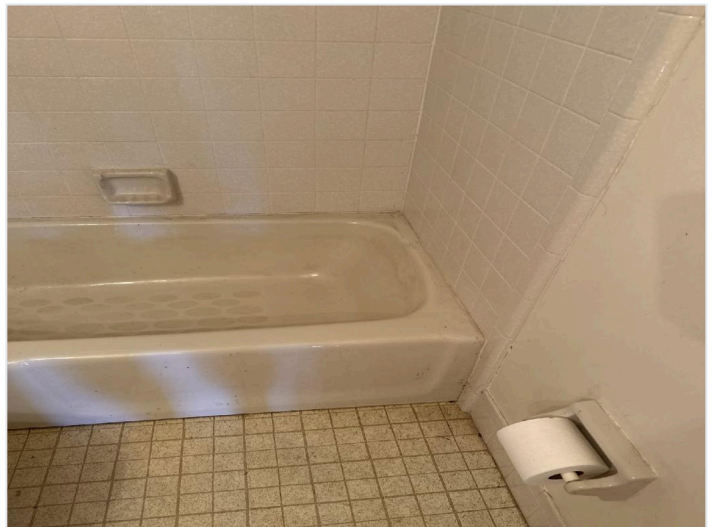
#### Shower - Condition

⚠ Dripping noted in shower faucet or showerhead. Recommend repair by plumber. 🚩

**Recommended:** Have a plumber repair the dripping shower faucet or showerhead to prevent water waste and damage.

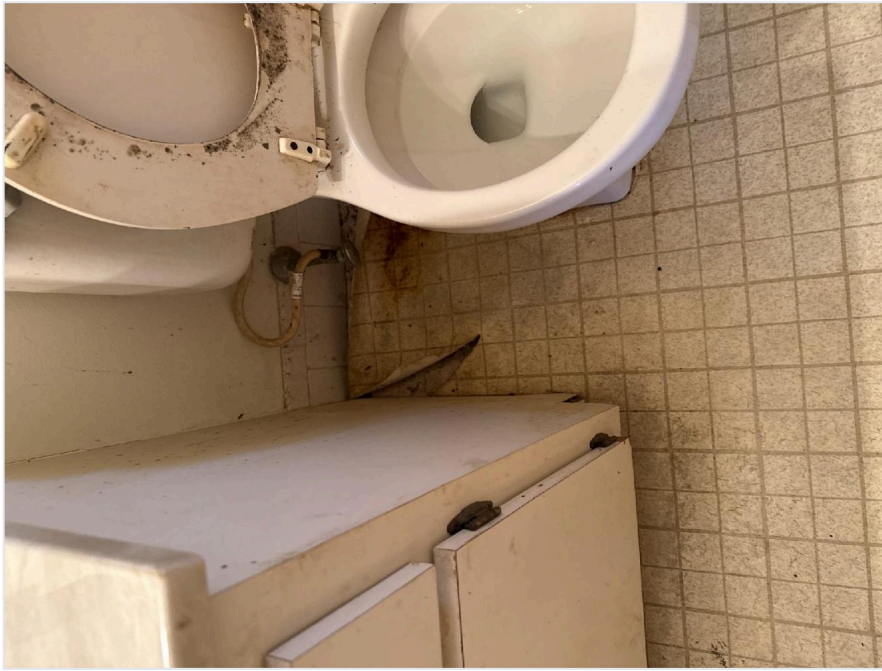
Floors - Condition

⚠ Loose floor tile(s) observed. Recommend evaluation and repair by flooring contractor. 🚩

**Recommended:** Have a flooring contractor inspect and repair or re-secure the loose floor tiles to prevent trip hazards and further deterioration.

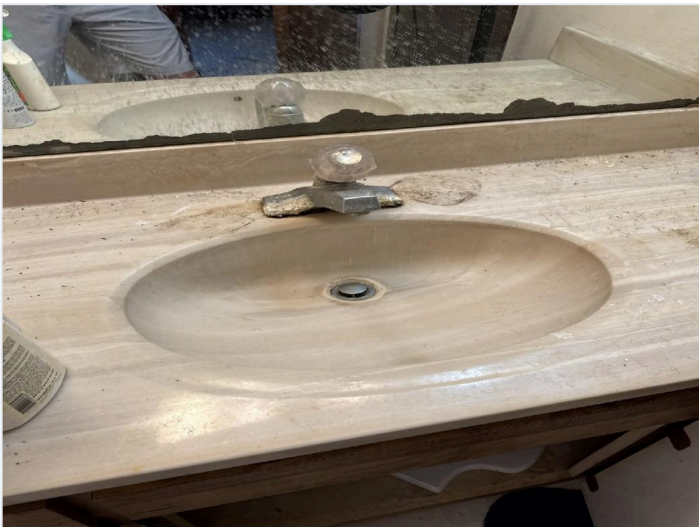
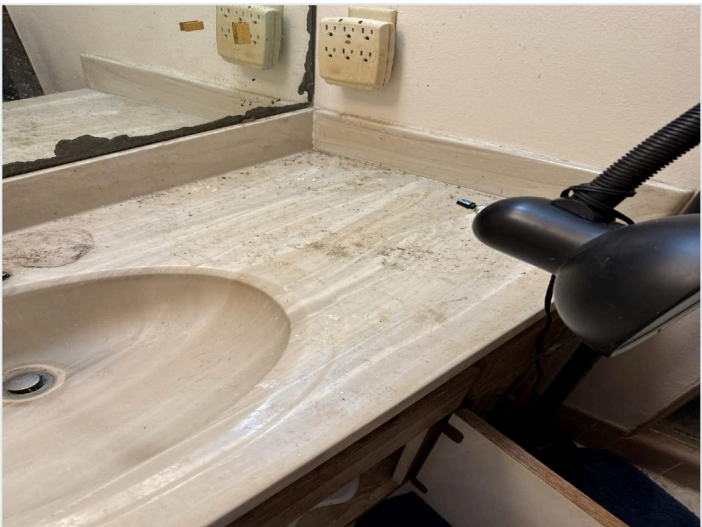
### Counters

⚠ The counter tops are noted as cracked or damaged. 🚩

**Recommended:** Have a countertop specialist repair or replace the cracked or damaged bathroom countertops.
