# Florida Wind Mitigation (OIR-B1-1802)

325 Sample St., Melbourne Beach

# Uniform Mitigation Verification Inspection Form

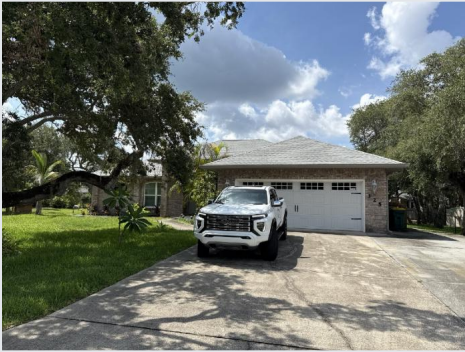
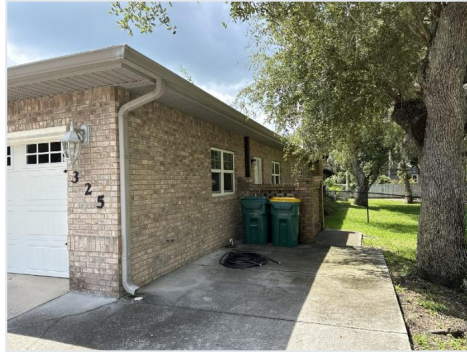
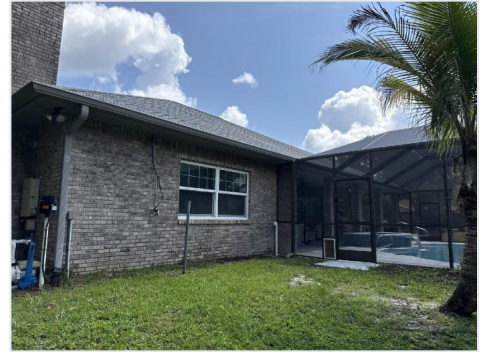
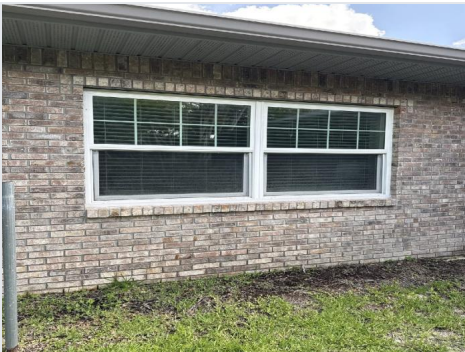
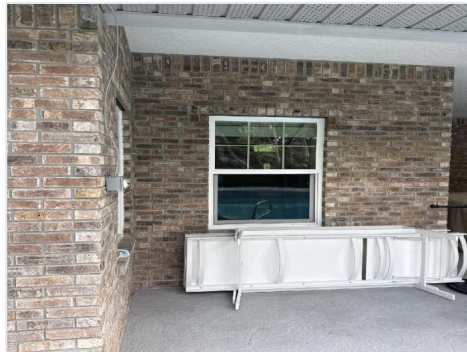
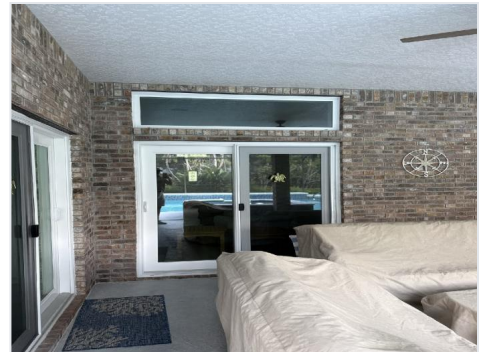
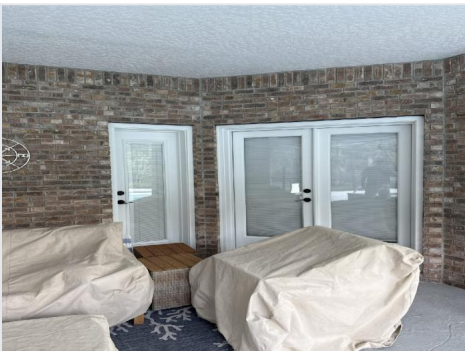
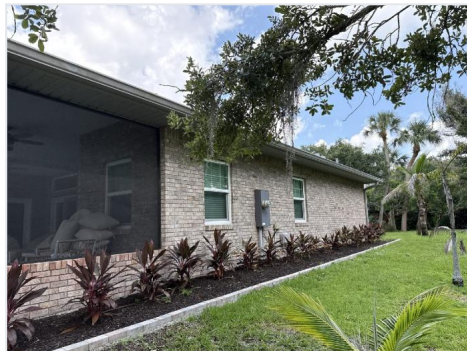
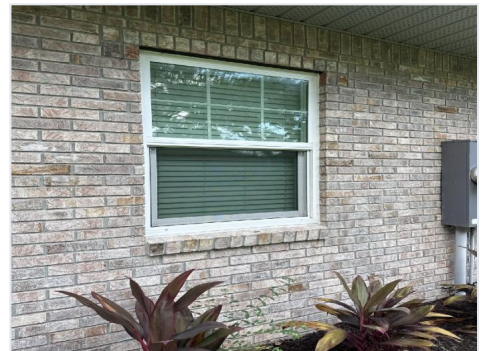
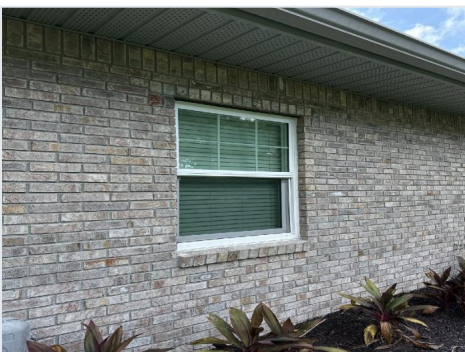
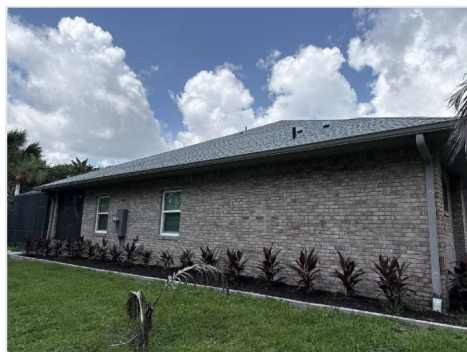
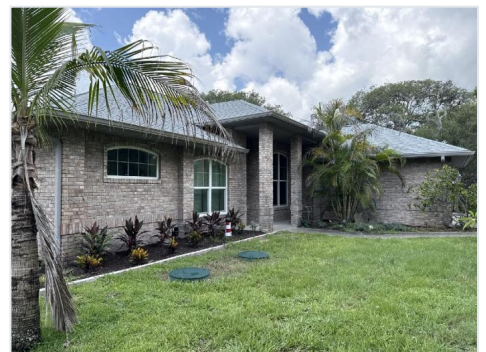
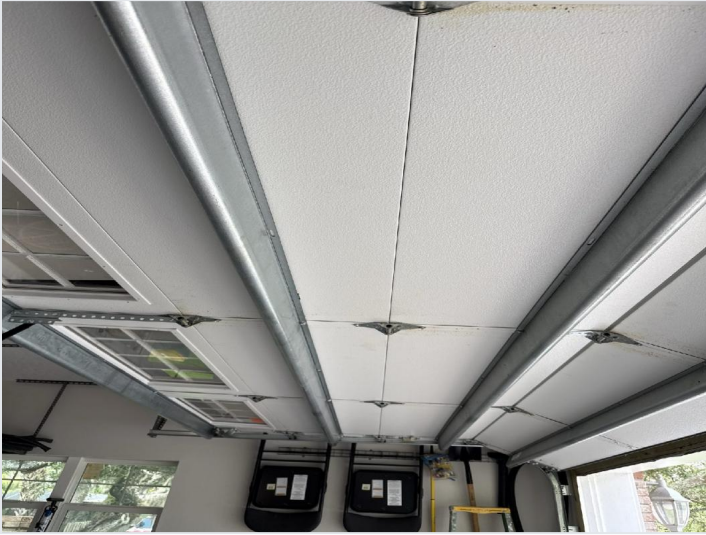
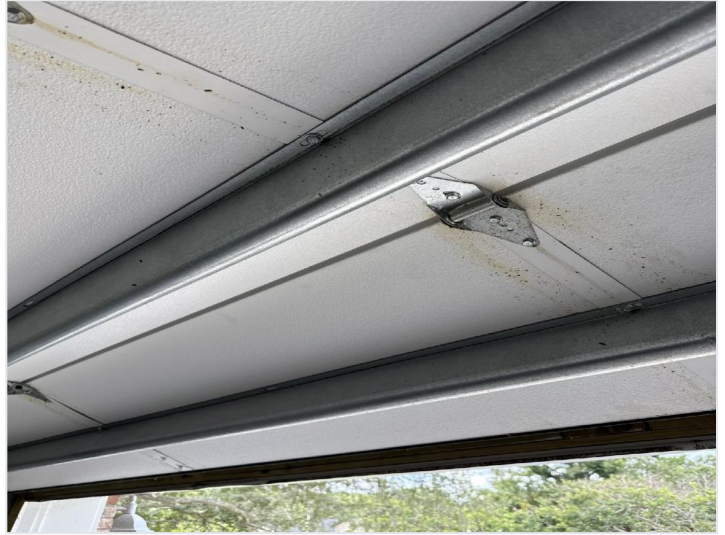
7. Roof Geometry

☒ A. Hip Roof: Hip roof with no other roof shapes greater than 10% of the total roof system perimeter.

Total length of non-hip features: 0 feet; Total roof system perimeter: 240 feet.

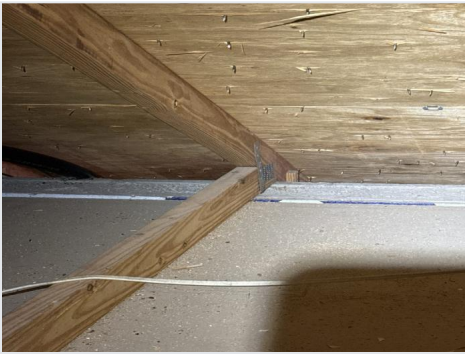
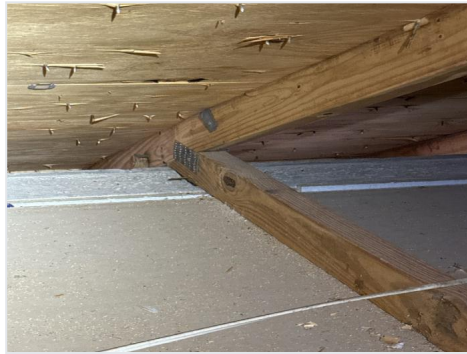
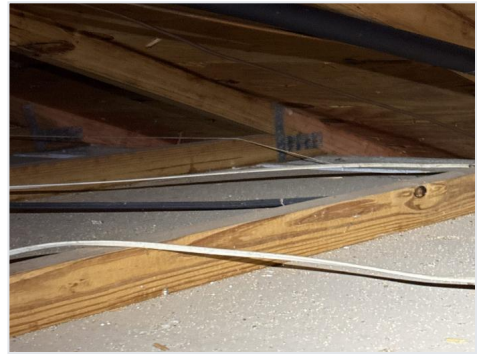
## 6. Roof to Wall Attachment

☒ C. Single Wraps:

- ☒ Metal connectors consisting of a single strap that wraps over the truss/rafter and are secured with a minimum of two (2) nails on one side and a minimum of one (1) nail on the opposing side, **OR**
- ☐ Purpose-made metal connector(s) or structural fastener(s) with a substantiated wind allowable uplift capacity of 535 lbs. or greater installed per the manufacturer's installation specifications (requires site-specific documentation).

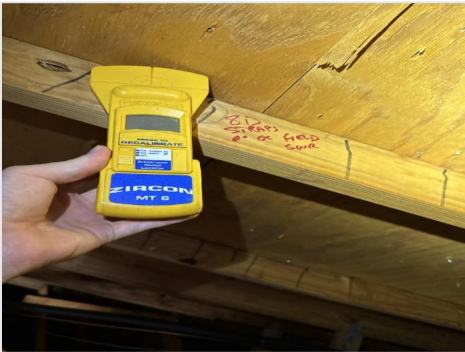
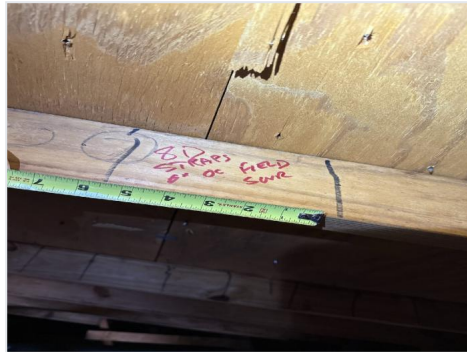
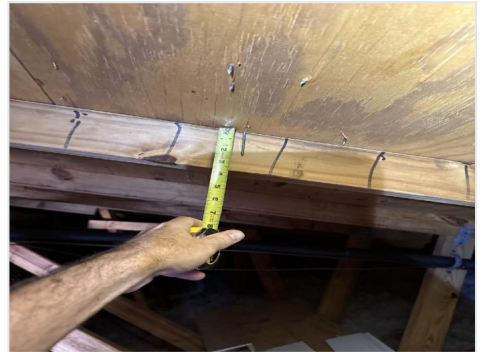
## 5. Roof Deck Attachment

- ☒ C. Plywood/OSB roof sheathing with a minimum thickness of 7/16" attached to the roof truss/rafter (spaced a maximum of 24" o.c.) by 8d common nails spaced a maximum of 6" in the field. **OR** Dimensional lumber/Tongue & Groove decking with a minimum of 2 nails per board (or 1 nail per board if each board is equal to or less than 6" in width). **OR** Any system of screws, nails, adhesives, other deck fastening system or truss/rafter spacing that is shown to have an equivalent or greater resistance than 8d common nails spaced a maximum of 6" in the field (max 24" truss/rafter spacing) or has a mean ultimate uplift resistance of at least 182 psf.

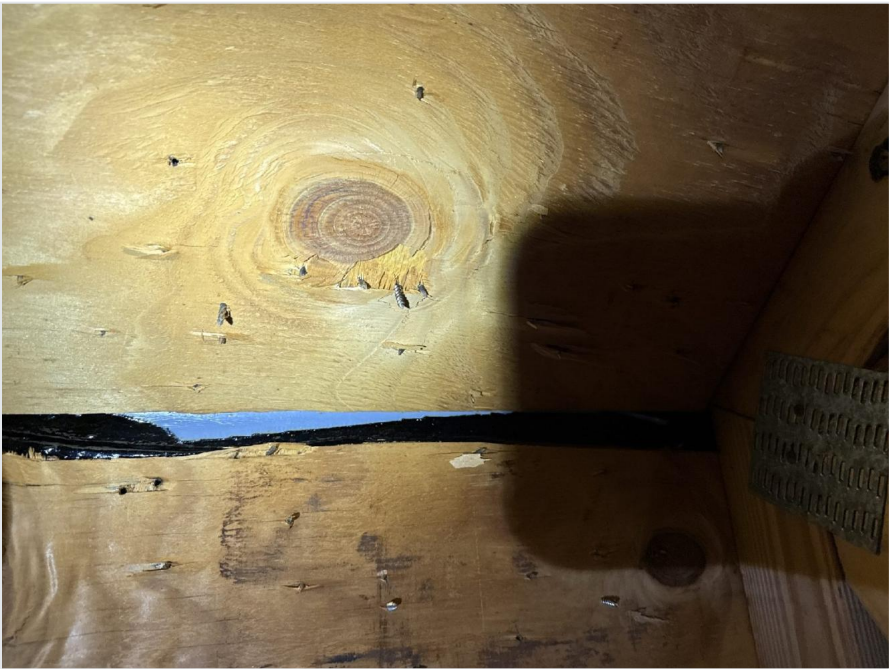
8. Secondary Water Resistance

☒ A. Sealed Roof Deck (also called SWR)

☒ Fully adhered polymer-modified bitumen roofing underlayment complying with ASTM D1970.
