SUREHOME OF BREVARD

# Full Home Inspection

PROPERTY INSPECTED  
450 Sample Way, Palm Bay

DATE INSPECTED  
July 29, 2026

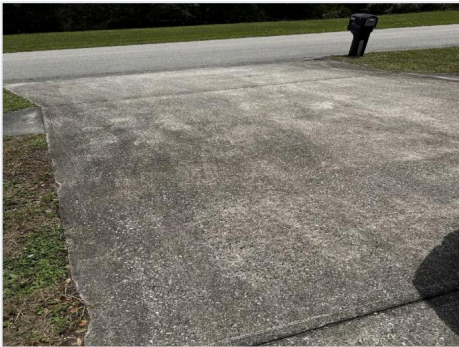
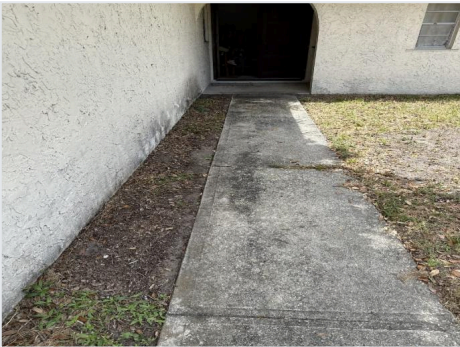
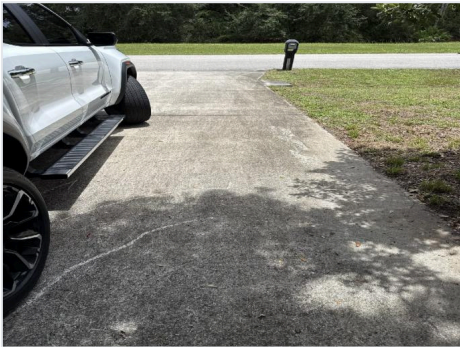
| ◆ Lot Features | |
|---|---|
| Driveway/Walkway Condition | Driveway is in serviceable condition with no significant observed defects. Recommend sealing to extend life. |

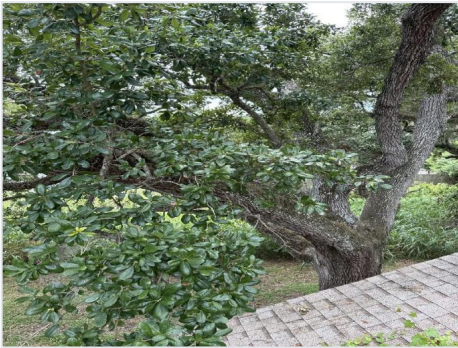
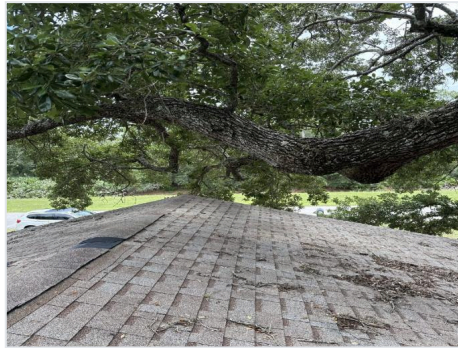
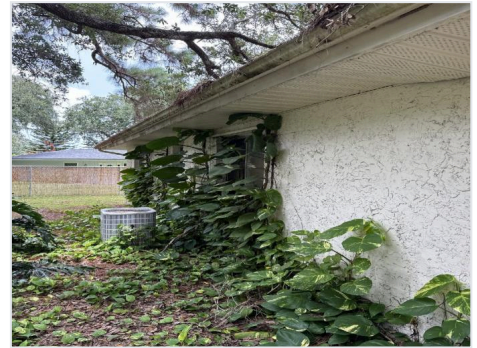
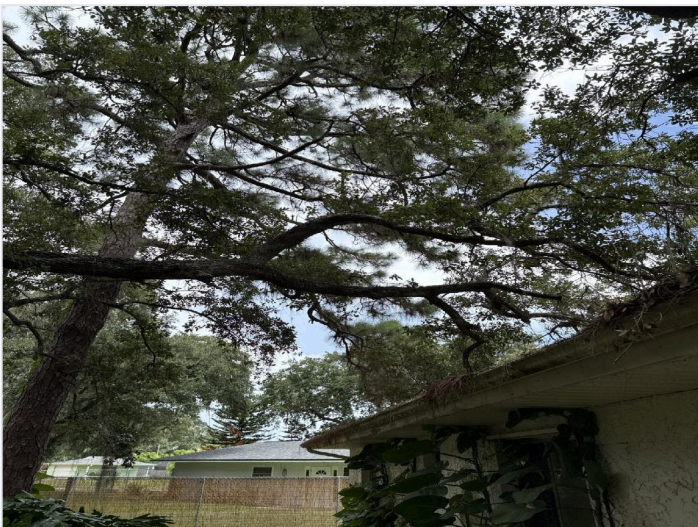
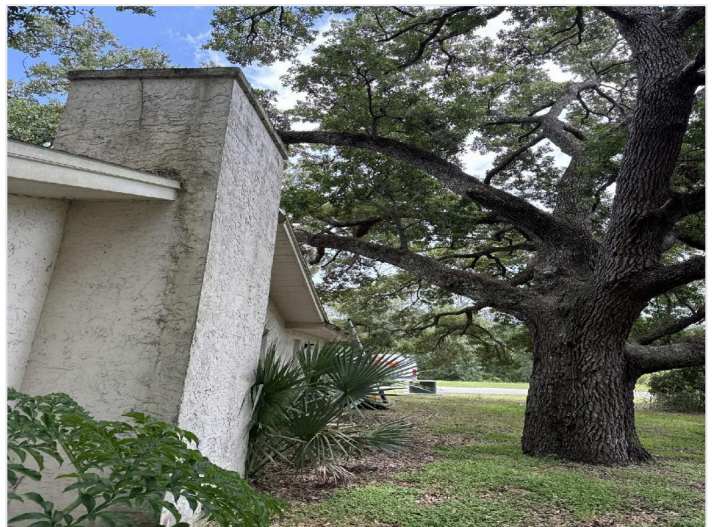
### Vegetation/Debris

⚠ Tree limbs within 10 feet of roof should be trimmed to provide air and sunlight, minimizing debris & dampness. Tree above roof should be removed. Cost \$6-8K 🚩

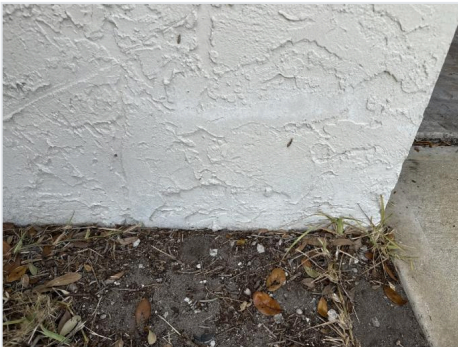
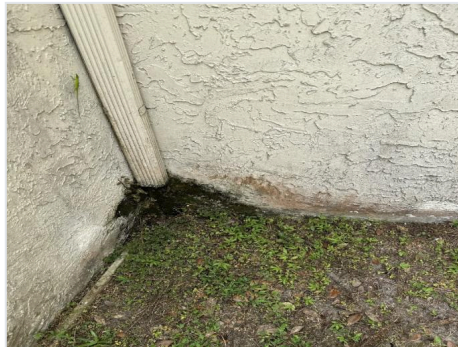
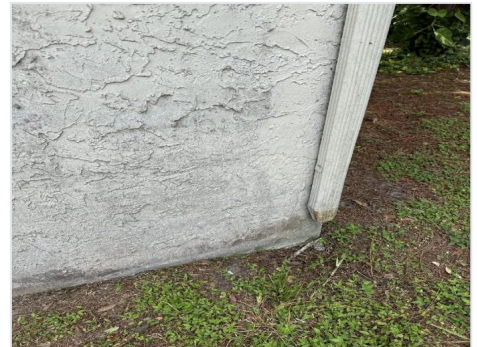
**Slab & Foundation**

All concrete slabs experience some degree of cracking due to shrinkage in the drying process. In most instances floor coverings prevent recognition of cracks or settlement in all but the most severe cases. Where carpeting and other floor coverings are installed, the materials and condition of the flooring underneath cannot be determined.

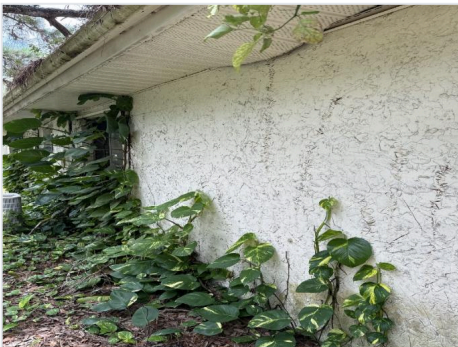
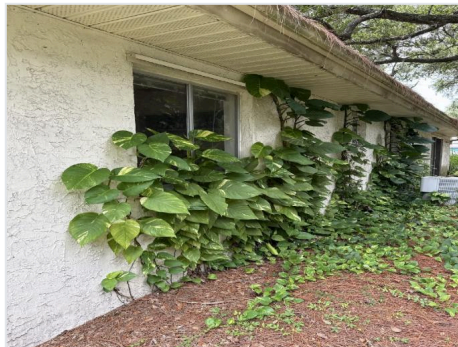
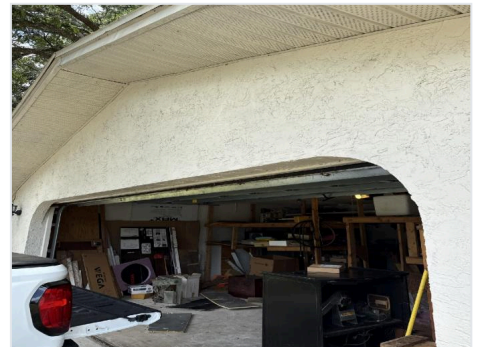
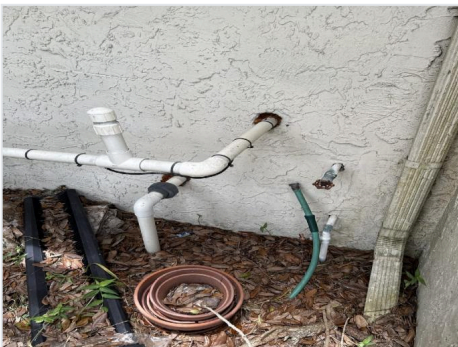
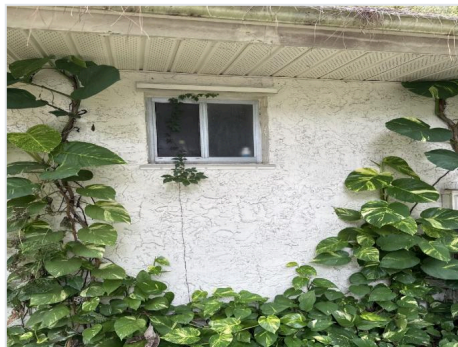
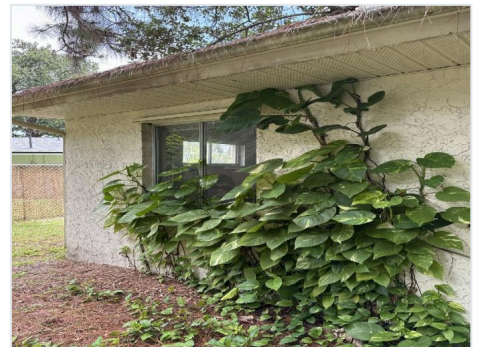
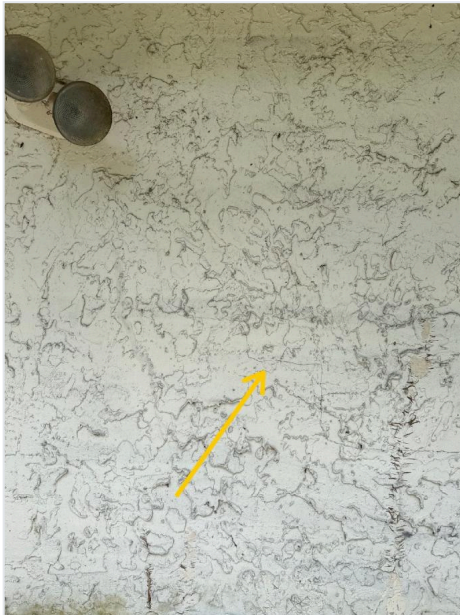
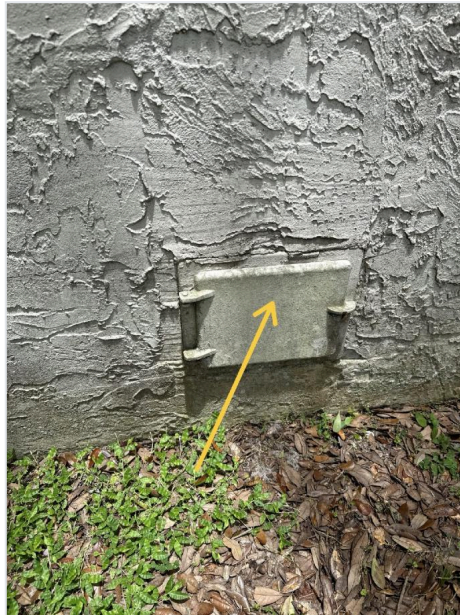
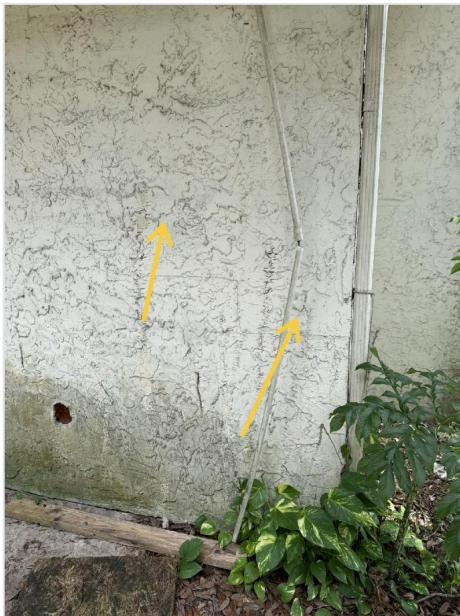
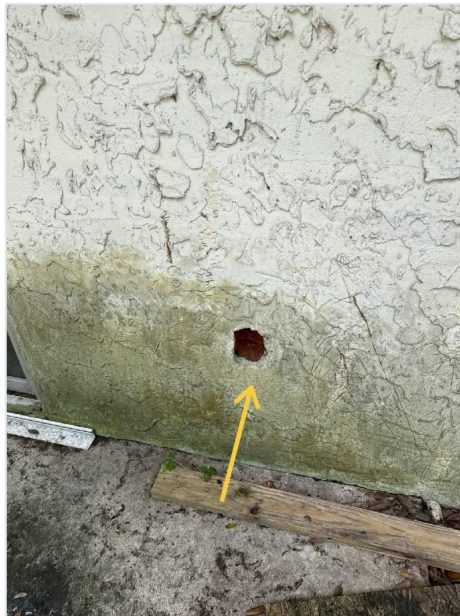
**Siding Condition**

- 1. House Exterior — Siding Condition** → p. 9  
Major damage to siding: Should be repaired to prevent moisture and insect intrusion of the wall assembly. Vegetation has taken over large areas of siding. Stucco cracks and large holes in stucco evident.

⚠ Major damage to siding: Should be repaired to prevent moisture and insect intrusion of the wall assembly. Vegetation has taken over large areas of siding. Stucco cracks and large holes in stucco evident.

**Recommended:** Have a licensed contractor inspect and repair major siding damage, remove vegetation overgrowth, and seal stucco cracks and holes to prevent moisture and pest intrusion.

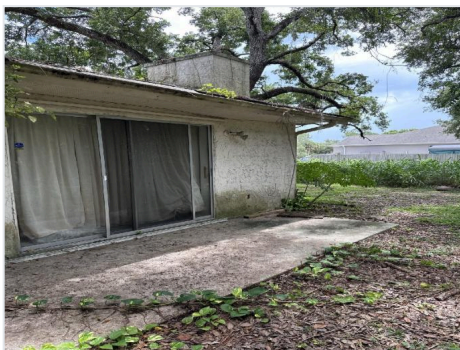
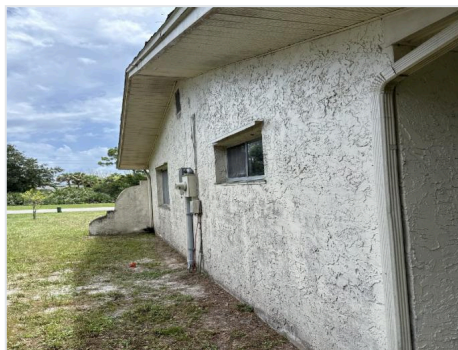
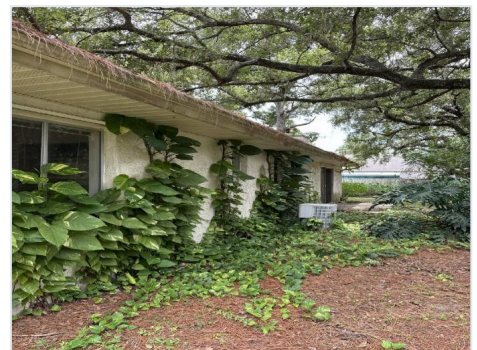
### Paint

⚠ The entire house needs stucco repair, sealing and painting to keep moisture from entering building envelope. 🚩

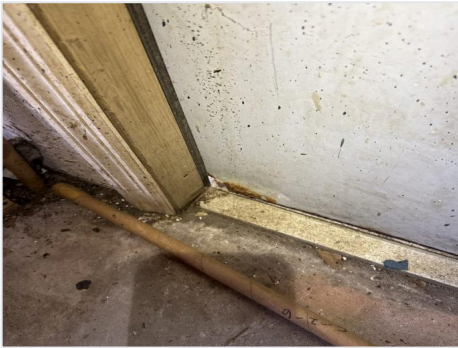
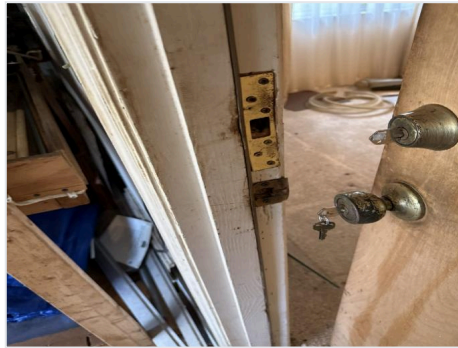
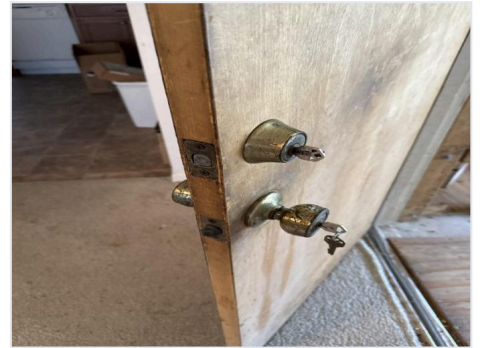
### Doors

- 2. House Exterior — Doors** → p. 9  
Side door didn't close or seal properly. Wood rot and rust at bottom. Door frame damage.  
**Recommended:** Have a licensed carpenter or door specialist repair or replace the side door, address wood rot and rust, and restore the door frame to ensure proper closure and sealing.

⚠ Side door didn't close or seal properly. Wood rot and rust at bottom. Door frame damage. 🚩

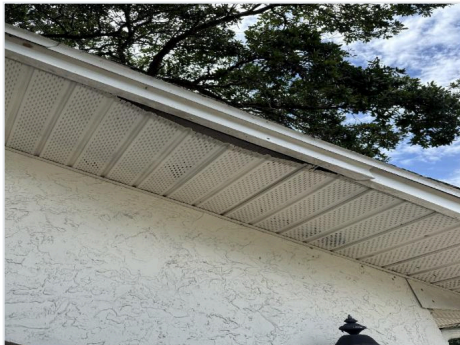
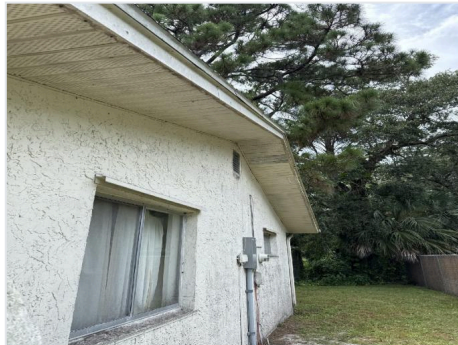
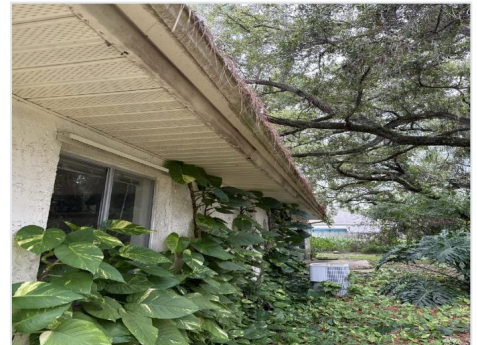
Soffits missing, loose or detached. Suggest repair or replacement.

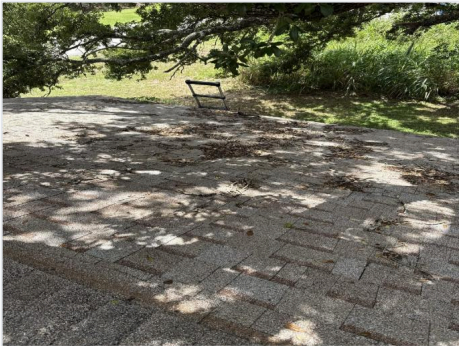
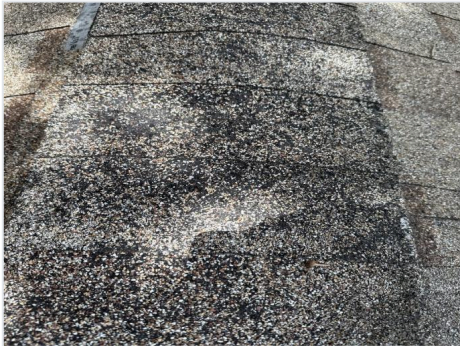
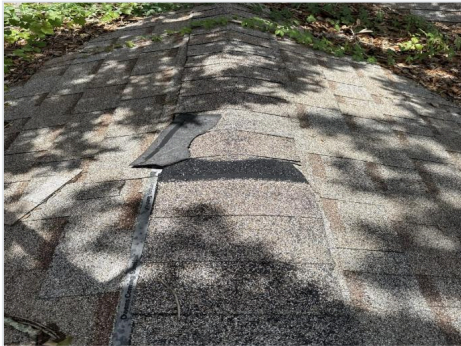
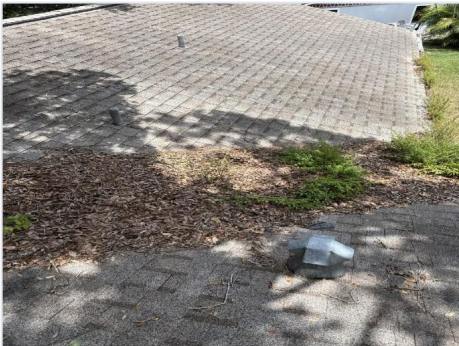
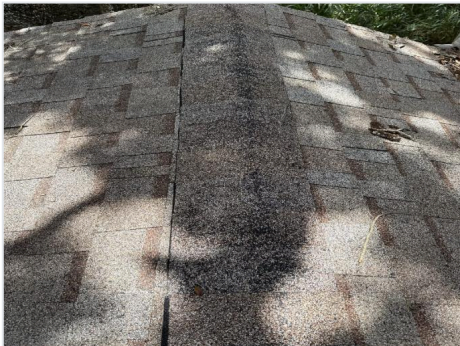
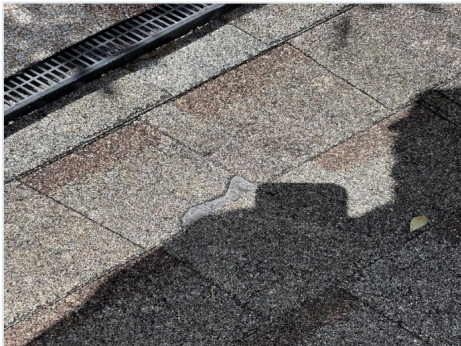
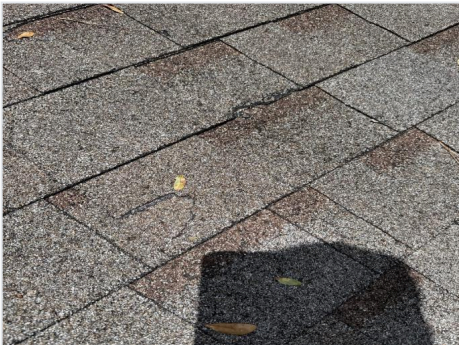
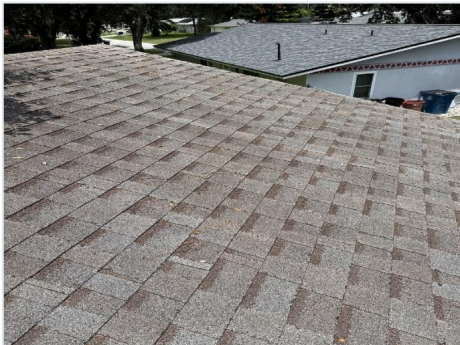
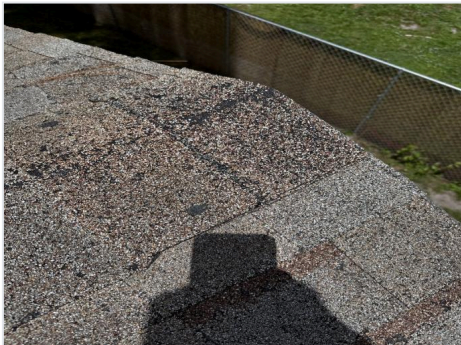
⚠️ Asphalt shingles noted. These roofs typically have a lifespan of

| | 25-30 years. Most recent permit for roof replacement is 2012. Roof is due to be replaced by the lack of maintenance and damage that the oak tree has done. <span>🚩</span> |
| Roof Inspection Type | <span>⚠️</span> Roof shows signs of aging and may be nearing the end of its useful life. Active leak evident. Ceiling below is caving in. New roof cost \$18-20K <span>🚩</span> |
| Roof Condition | <span>⚠️</span> Roof shows signs of aging and may be nearing the end of its useful life. <span>🚩</span> |

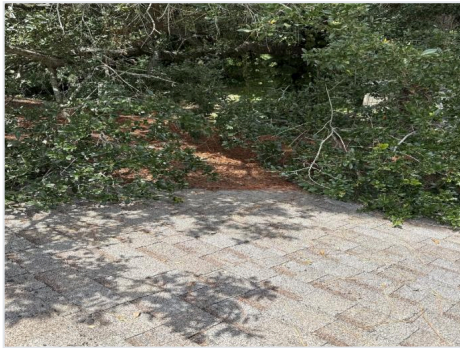
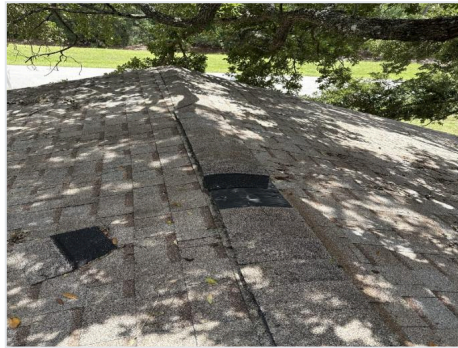
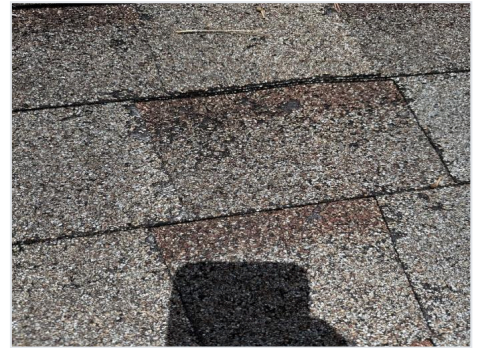
⚠ In the inspectors opinion the flashings are near the end of their useful life due to wear. Flashing around chimney is failing and causing leaks into flue housing. 🚩

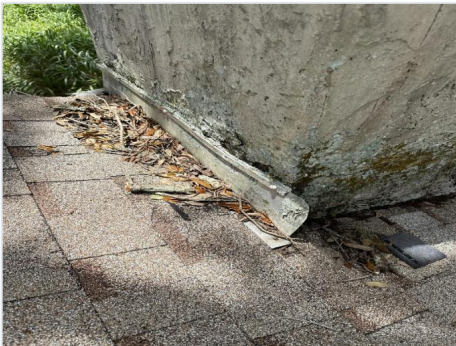
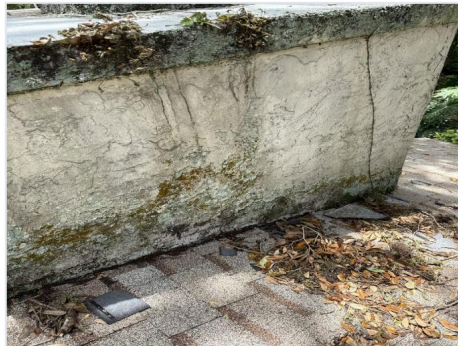
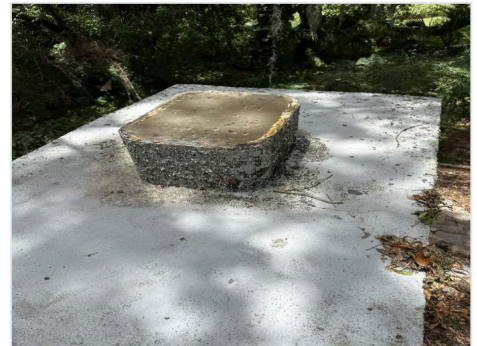
Chimney

⚠ Flashing at base of chimney appears to need some maintenance to ensure a continued waterproof seal. 🚩

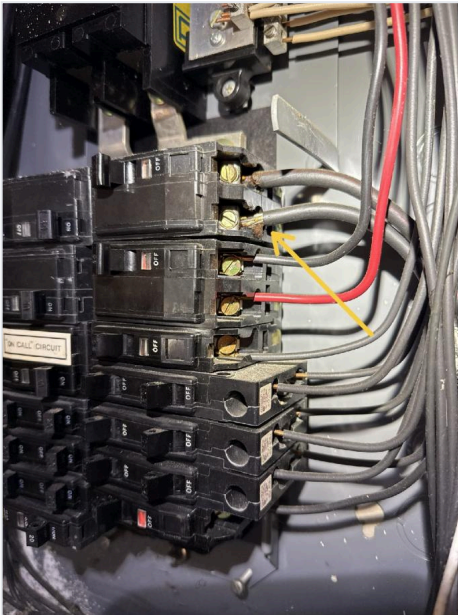
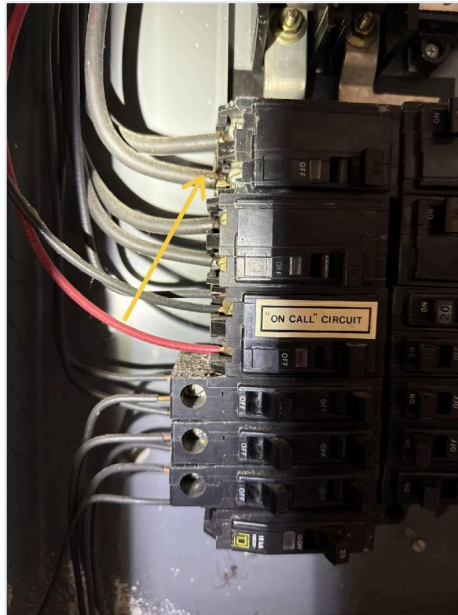
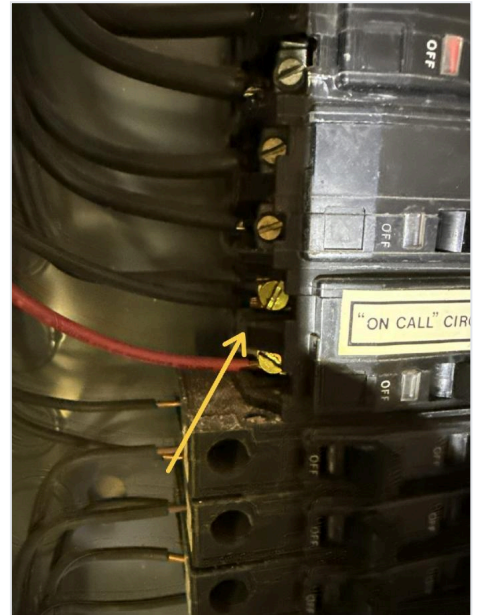
#### Panel Condition

| Panel Issues | <p>Copper non-metallic sheathed cable noted.</p> <p>⚠️ Aluminum non-metallic sheathed cable noted. Considered a fire hazard by many insurance companies. Common for 1975-1985 builds.</p> <p>⚠️ Double tapped breaker(s) inside panel box (more than one electrical wire attached). This is not standard practice, and may cause overheating or even an electrical fire. Recommend evaluation by an electrician. 🚩</p> |

⚠ Open breaker panel slot(s) at panel box cover present a hazard. Recommend installation of caps.  
Panel cover screw(s) missing. Recommend replacement by electrician.

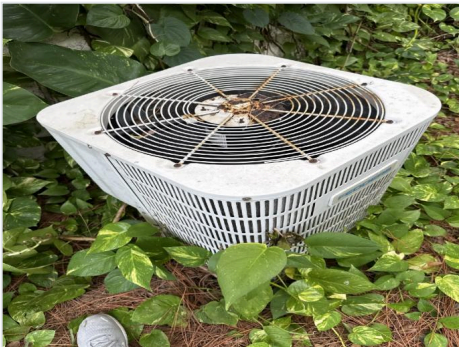
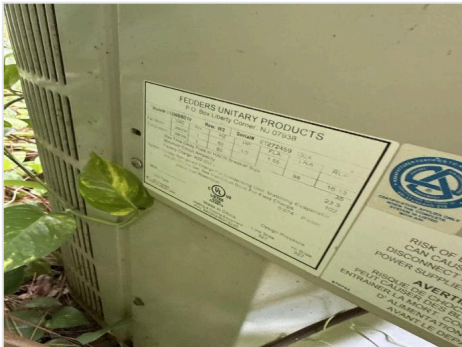
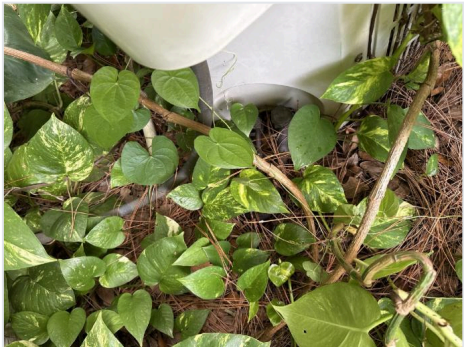
| HVAC Condition | ⚠️ Recommend cleaning and yearly maintenance of AC compressor. Compressor has vegetation very close or on unit. This will cause early failure. 🚩 |
| Refrigerant/Drain Lines | ⚠️ Recommend adding insulation at A/C refrigerant lines to prevent condensation and energy loss. 🚩 |

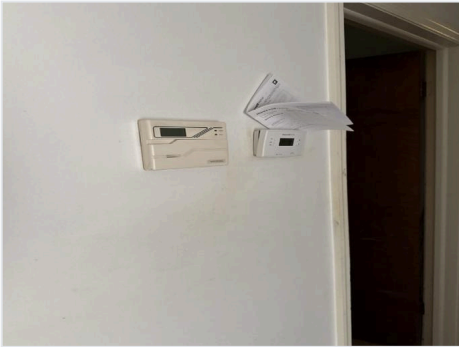
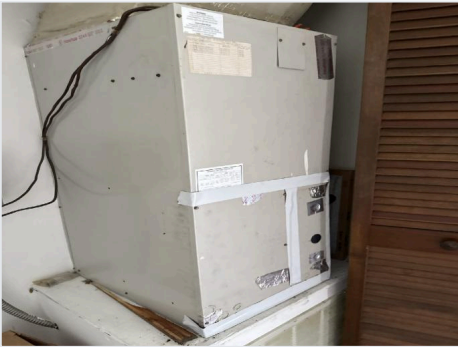
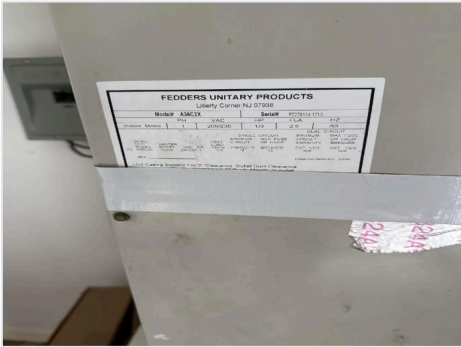
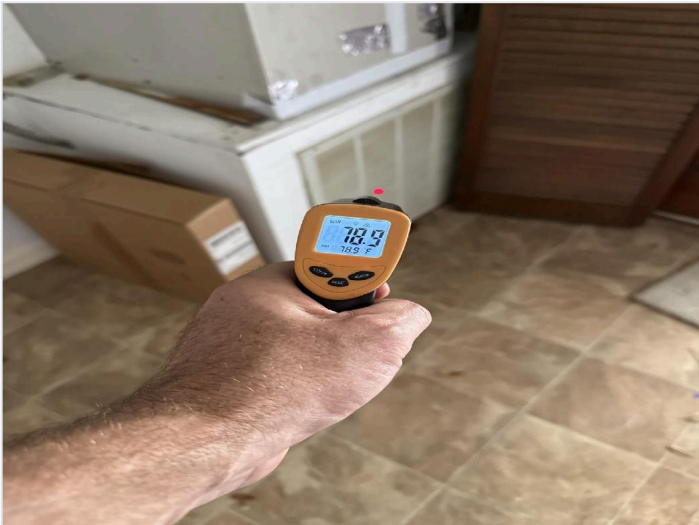
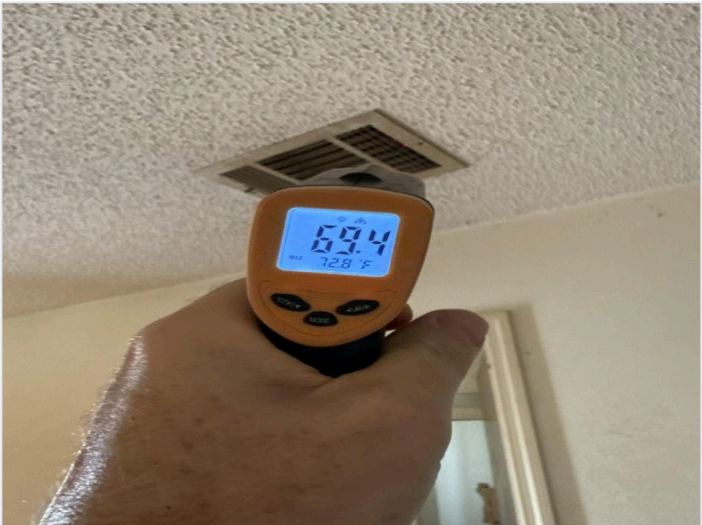
| Zones/Handler Condition | The air handler appears to be in satisfactory condition. |

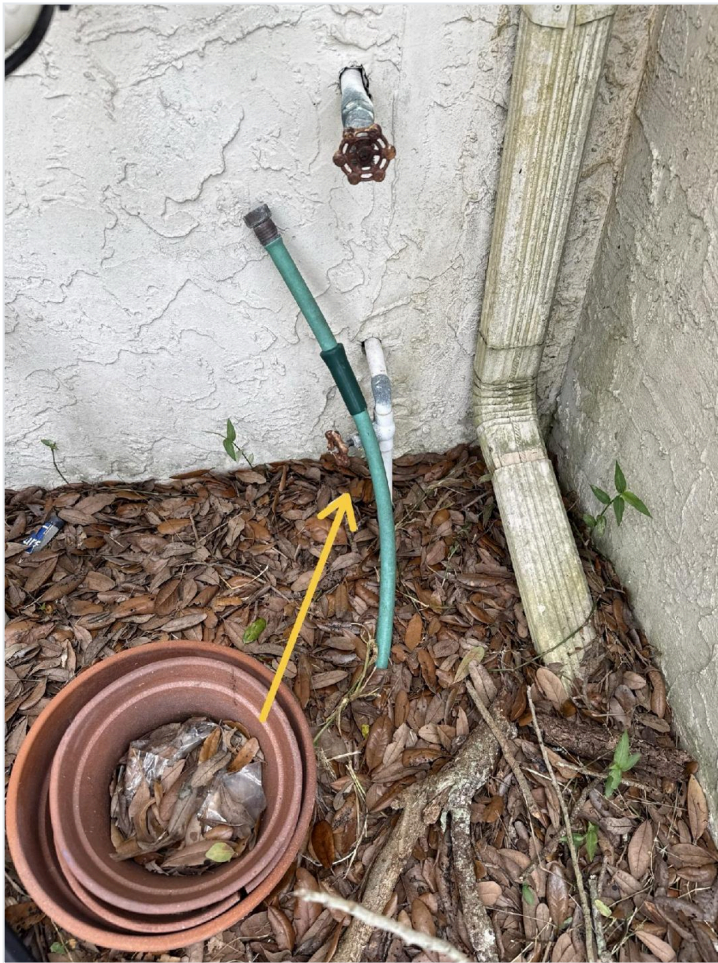
Plumbing shutoff valve and visible parts of piping show no current signs of defects or leaking.

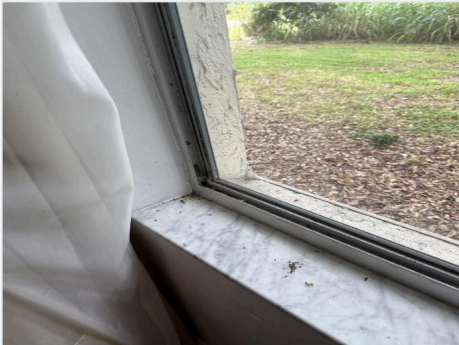
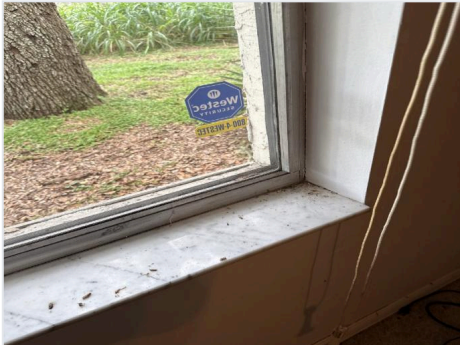
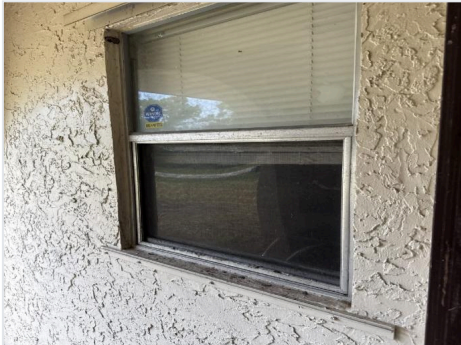
- ⚠ Window hardware damaged. Recommend repair.
- ⚠ Window binds in frame. Recommend evaluation by window specialist. 🚩

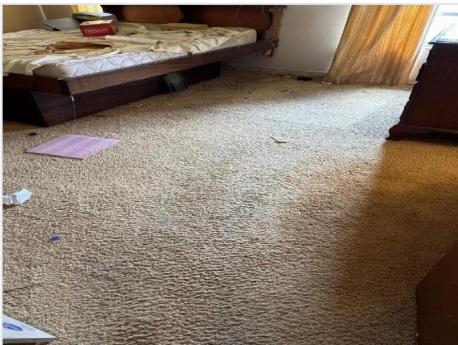
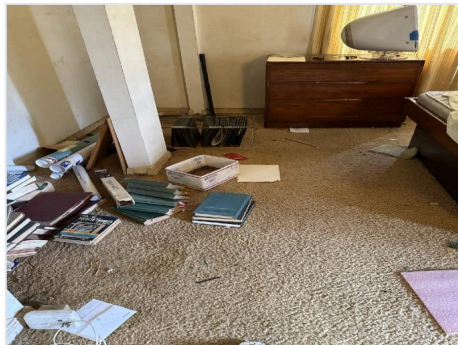
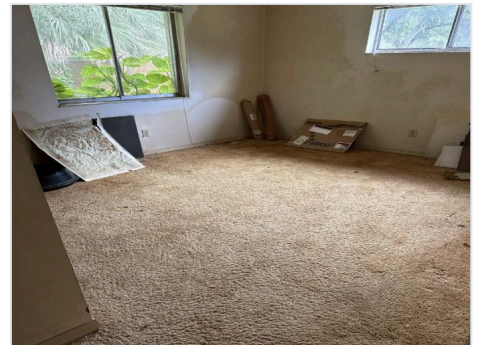
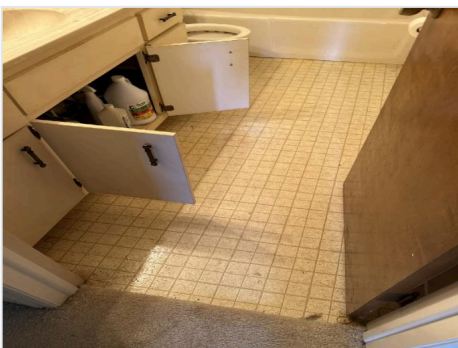
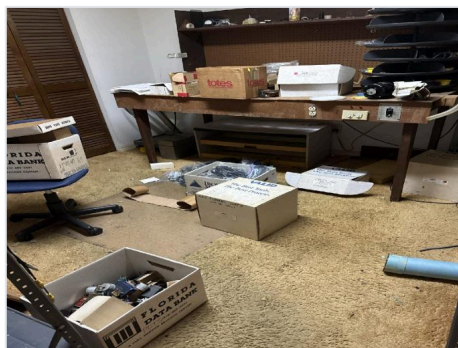
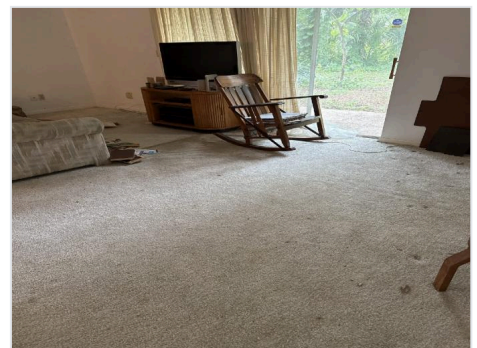
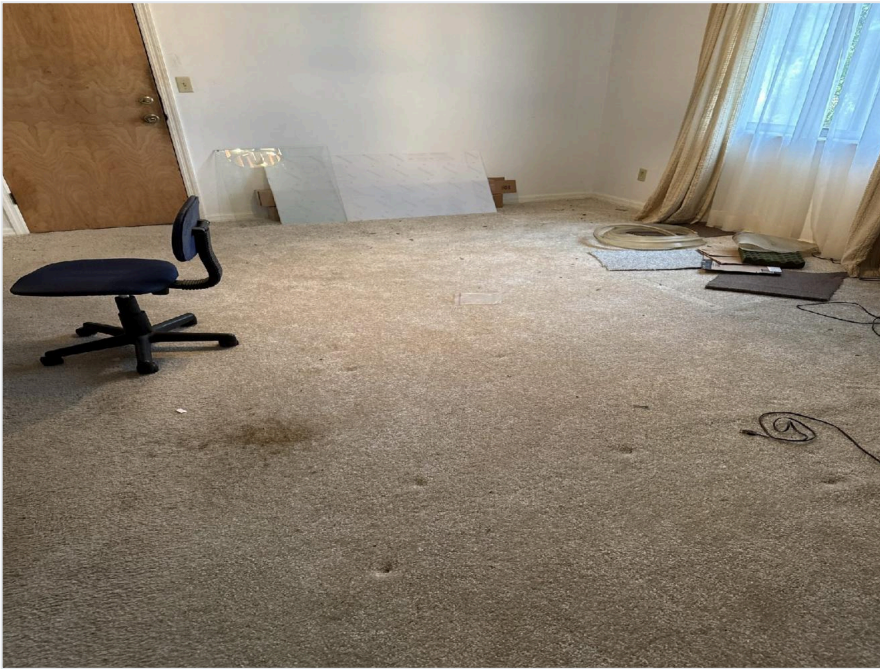
⚠ Water damage observed on flooring. Windows likely leak in a wind-blown storm. 🚩

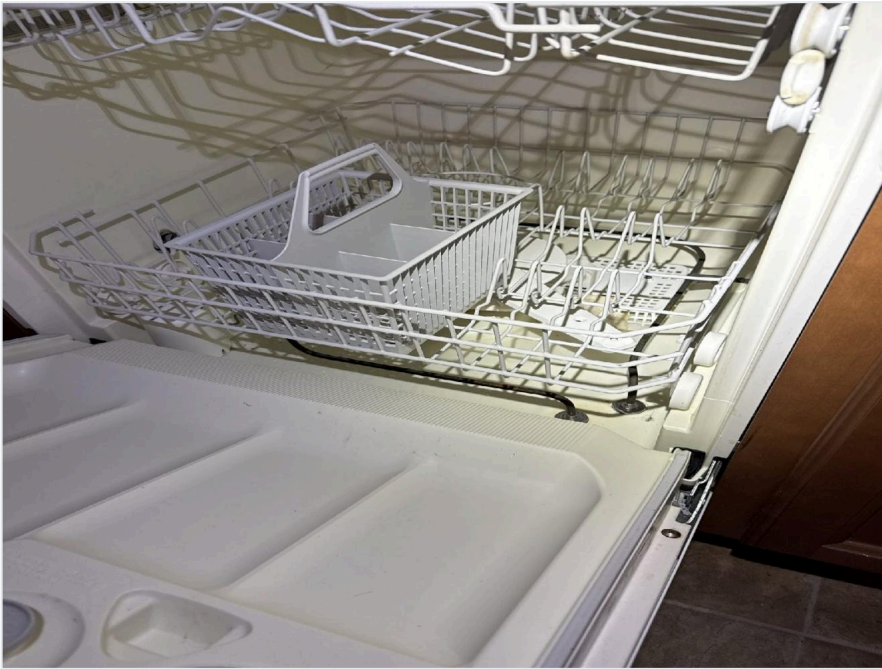
⚠ Dishwasher was visually reviewed and operated through a cycle during the inspection. Did not drain. 🚩

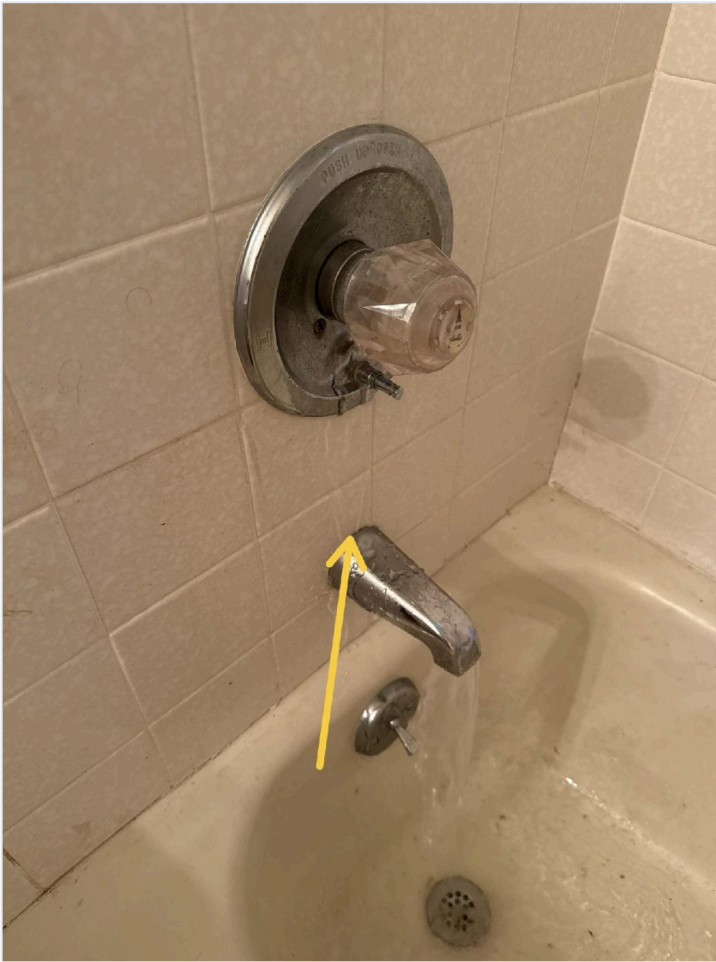
⚠ Dripping noted in shower faucet or showerhead. Recommend repair by plumber. 🚩

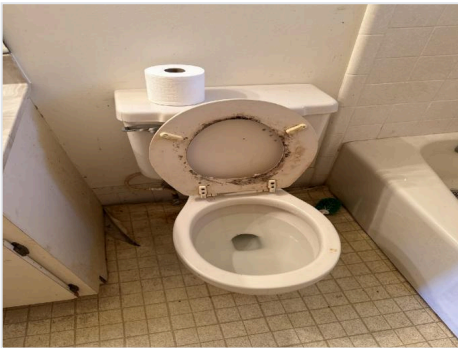
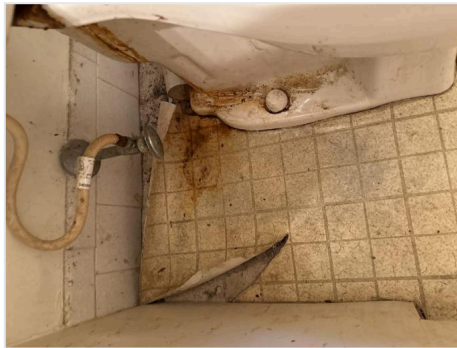
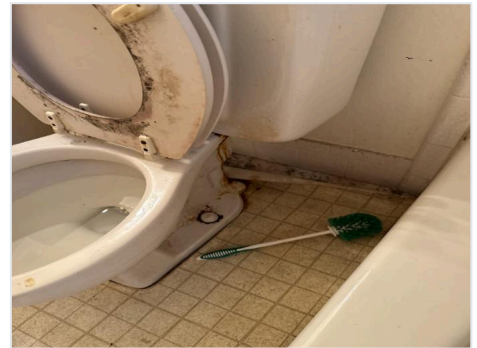
⚠ Loose floor tile(s) observed. Recommend evaluation and repair by flooring contractor. 🚩

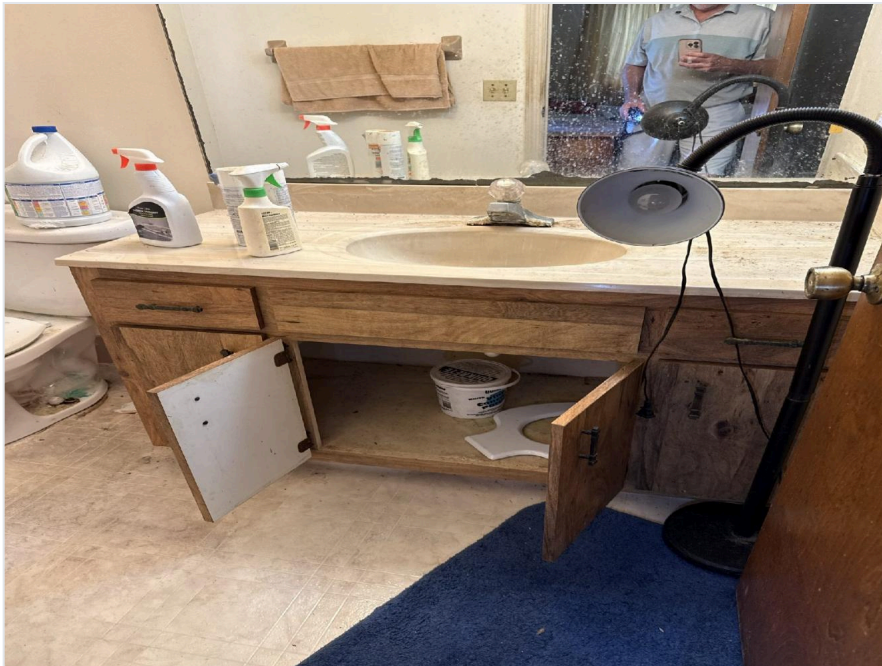
⚠ The counter tops are noted as cracked or damaged. 🚩

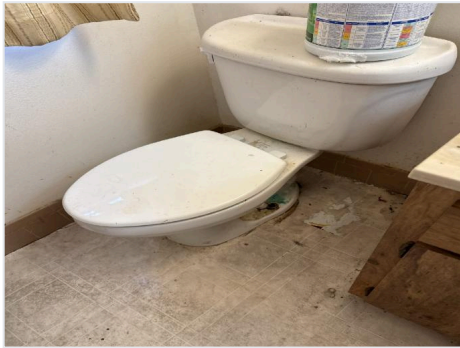
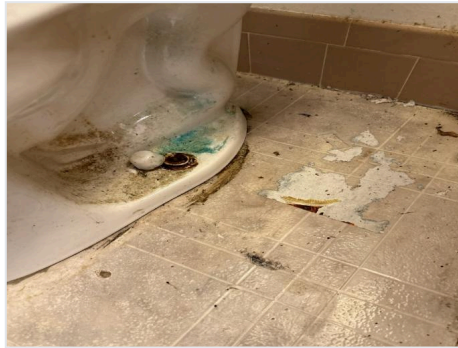
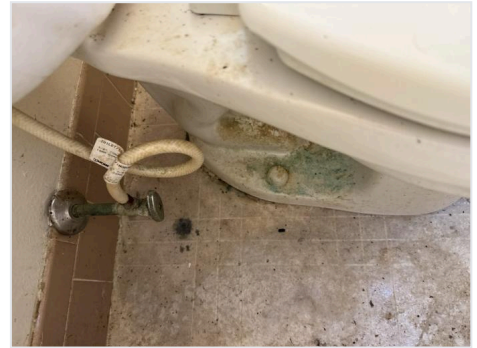
⚠ Toilet not secure at floor, which may lead to leakage. Recommend evaluation by a licensed plumber. 🚩

⚠ Loose floor tile(s) observed. Recommend evaluation and repair by flooring contractor. 🚩
